SRP IBR Oscillation Event Report for 9/20/23, 11/1/23 and 11/3/23 Events

September 20, 2023 IBR1 BESS Oscillation Summary

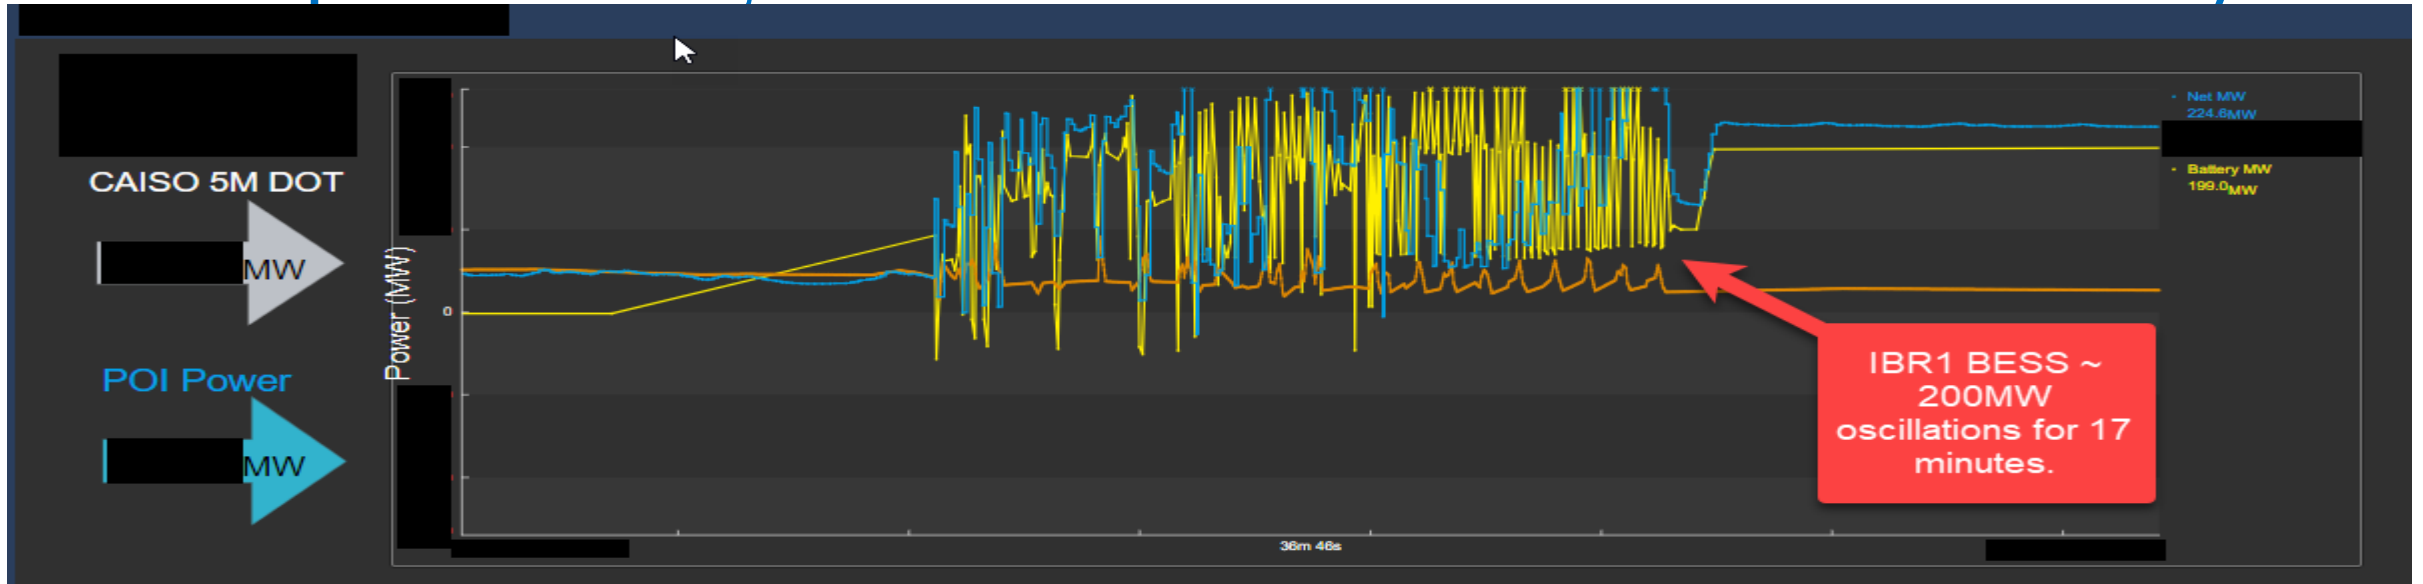
- **Event details:** Event identified after RC West called SRPs control room via Pi Vision displays. IBR Operator was able to take the unit to local to arrest the oscillation.

- **Cause:** Error in the Metering Loss Compensation Methodology
- **Solution:** Near term - Logic reverted to use uncompensated meter data. Long term – Fix compensated meter data and put back in place at this and other IBR operated sites for SRP – fix began 12/11/23 estimated completion 1/15/24.

- **WECC Impact:** Frequency of forced oscillations (0.25 Hz) was close to that of NS-A mode frequency causing the Modemeter to trigger alerts for NS-A mode critical damping ratio. Actual damping ratio remained unaffected (The damping ratio of a mode is essentially biased in the presence of forced oscillations having frequency close to that of the mode). RC West mode meters detected forced oscillation. RC West and BPA ODM (Oscillation Detection Module) tool detected forced oscillations with low damping ratio alerts triggered in the RC West Modemeter for NS-A mode. Oscillations in current and frequency across major WI 500kV lines.

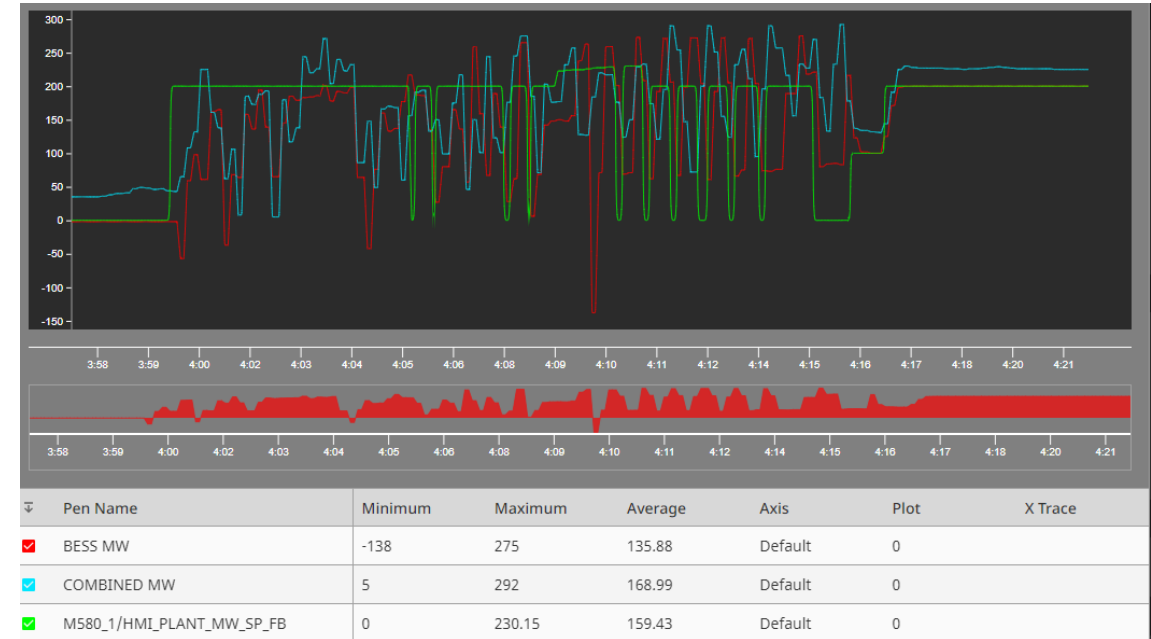
- Battery site was in an idle state when the site controller received a 200 MW discharge setpoint
- Site began to ramp but started oscillating prior to reaching the 200 MW discharge
- Oscillations lasted 17 minutes where maximum recorded output was 275 MW and minimum was -138 MW
- The site was placed in local mode with a 200 MW setpoint and followed that dispatch stopping the oscillations

Significant power output swings observed after site responded to discharge dispatch instructions

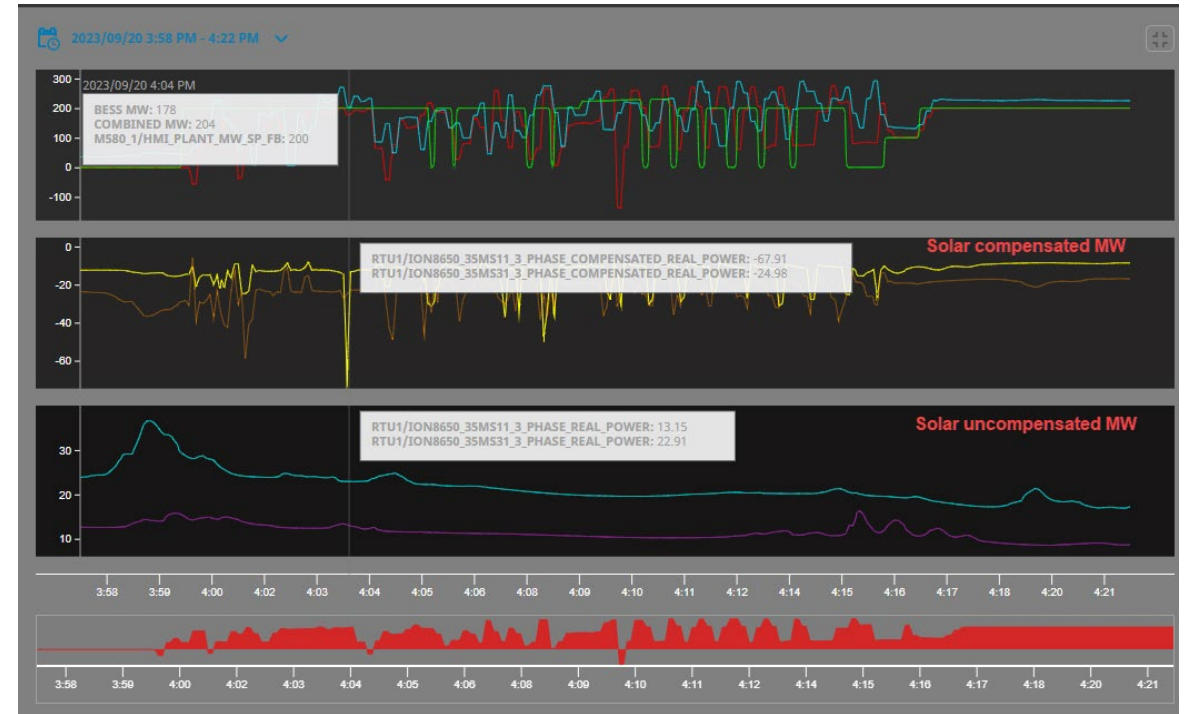
- The metering EOR developed an algorithm to calculate losses for solar production when solar was passing through the transformer even when solar was charging the BESS
- This algorithm was approved by the operator and SRP and was tested by the operator with passing results
- The oscillation proved the compensated MW values were not plausible
- It was determined under certain conditions the algorithm would cause a divide by zero error that greatly increased the compensated MW values beyond the actual MW capacity of the site.

Under certain conditions, the algorithm used to calculate losses on the solar production caused a divide by zero error resulting in oscillation

- On 9/24 the loss compensation logic was disabled in the meters for the solar charging BESS conditions
- New loss compensation logic has been written to eliminate the divide by zero scenario which has been approved by SRP and is currently being implemented by the metering EOR
- PLC compensation block will be revised to match the meter logic
 - Then, the PLC will control the power based on compensated power values

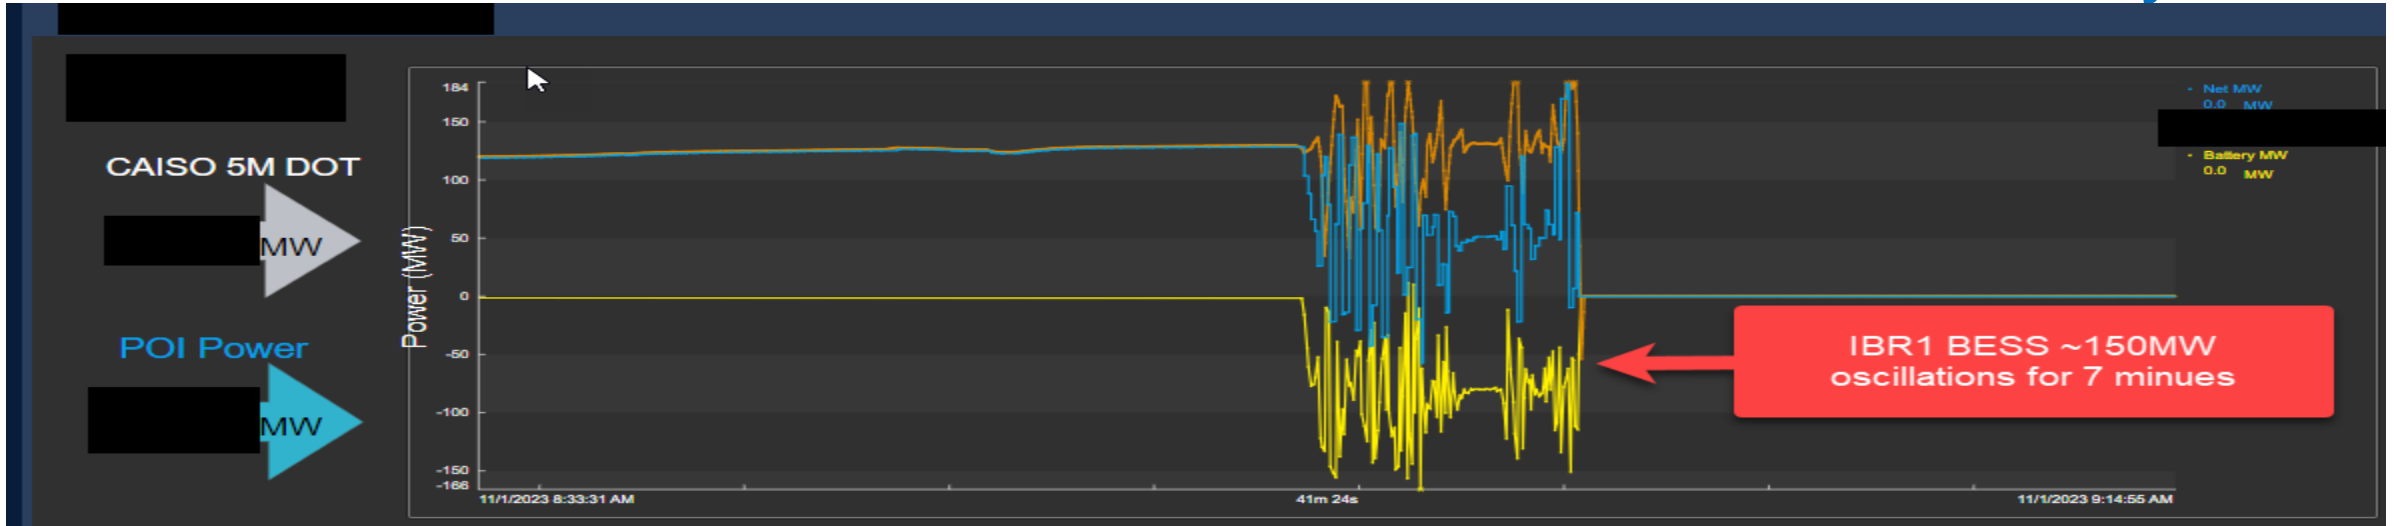
- **Event Details:** SRP control room operators via the PI Vision displays, noticed the oscillation and called IBR Operator to address. Following 9/20 event, SRP implemented a POI breaker tripping procedure after 3 minutes of oscillations present. The event here looked to stabilize partway through the event. Once the oscillation re-engaged, SRP opened the POI breakers.

- **Cause:** Three GSUs delivered output with differing polarity (some discharging, and some charging) that resulted in erroneous GCU MVA limits. Severity of event aggravated by delayed inverter startup which was sourced from a control's integrator error the previous day to shut down all inverters for controller changes rather than placing inverters in idle. Some inverters were driven to startup upon receiving a non-zero dispatch command which led to unbalanced inverter startup.

- **WECC Impact:** Frequency of forced oscillations (0.25 Hz) was close to that of NS-A mode frequency causing the Modemeter to trigger alerts for NS-A mode critical damping ratio. Actual damping ratio remained unaffected. BPA operators thought the oscillations were caused by unstable NS-A mode and inserted series capacitors to improve mode damping ratio with essentially no effect. RC West and BPA ODM tool detected forced oscillations with low damping ratio alerts triggered in the Modemeter for NS-A mode.

- **Solution:** Fixed logic to ensure all inverters from all three GSUs are started up regardless of MW commands to site which also protects against potential inverter startup from a shut down state. GCU MW limit logic fixes put in place to prevent output signal polarity inversion.

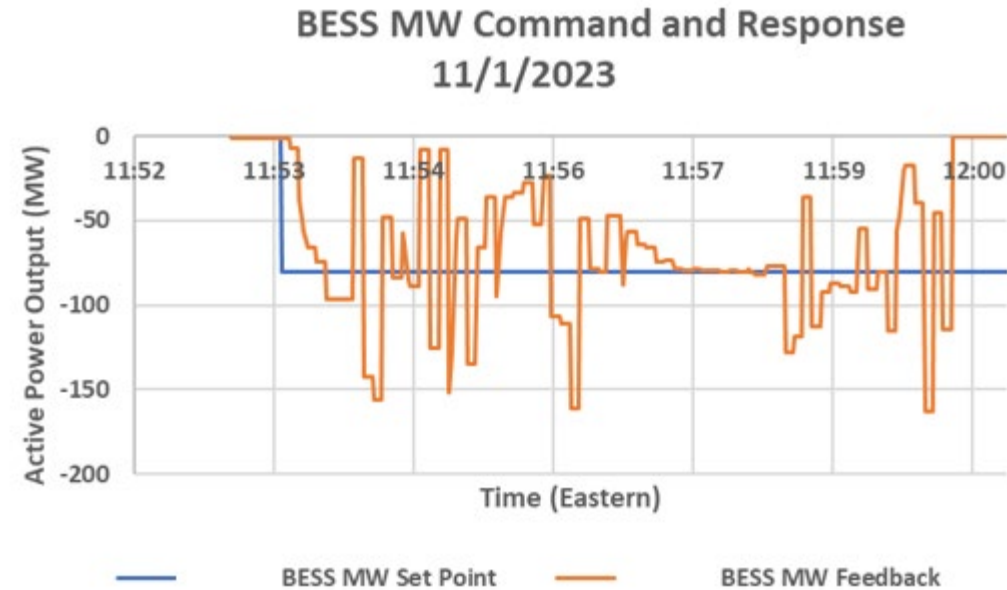
- Battery site was dispatched from a 0 MW setpoint to 80 MW charge at ~11:53 EST on 11/1/2023
- Site ramped to -80 MW and began oscillating, with maximum output of ~-8 MW and minimum of -160 MW
- Adjacent PV site under commissioning and was injecting power at time of event

Significant power output swings observed after site responded to charge dispatch instructions

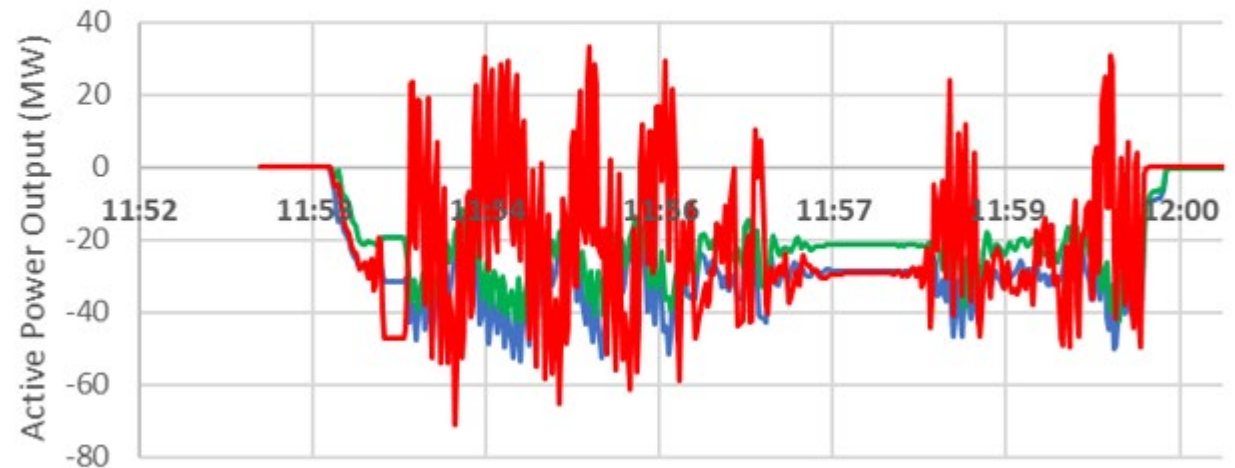
BESS Sum of Inverter MW
Output: GSU 1, 2, and 3 - 11/1/2023

- Site had control system update pushed on 10/31/23
 - Adjusted Ymin/Ymax values that reduced maximum and minimum values that can be commanded from site controller
 - Update was done by taking PLC offline and restarting controller
 - Not standard update practice for operating units
- Oscillation was not consistent between the 3 site GS transformers
 - GSUs 1/2 showed similar behavior, GSU 3 had more aggressive output swings

Inconsistent output swings observed across different portions of the facility. Differences in response between GSU Transformers indicate issue was not created by site level PID control, but with GSU-level translation of site commands

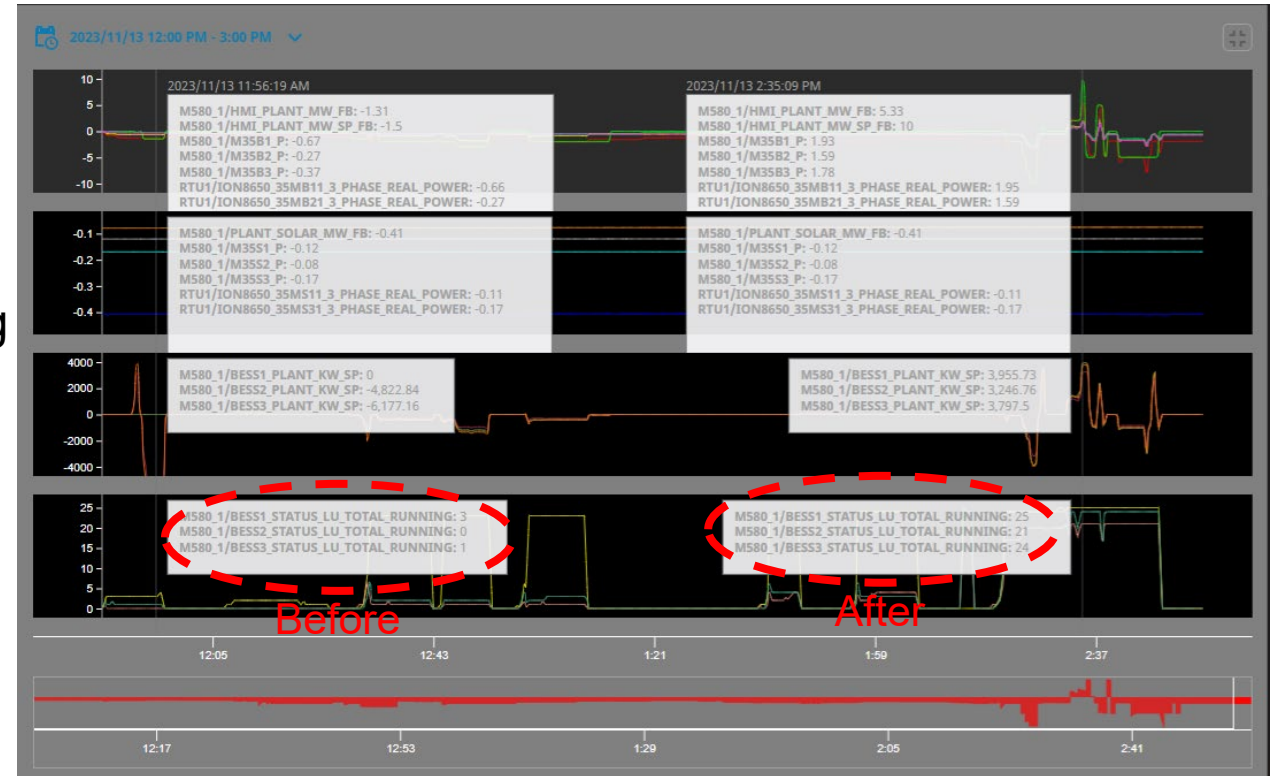
- The control update from 10/31/23 created condition that required all inverters on site to go through extended start sequence
 - Likely resulted in portions of the site waking at different times, creating an unbalanced condition that could shift load to specific portions of the facility
- Testing confirmed asymmetric starts between transformers

Differences in response between GSU Transformers suspected of driving GSU near MVA limit

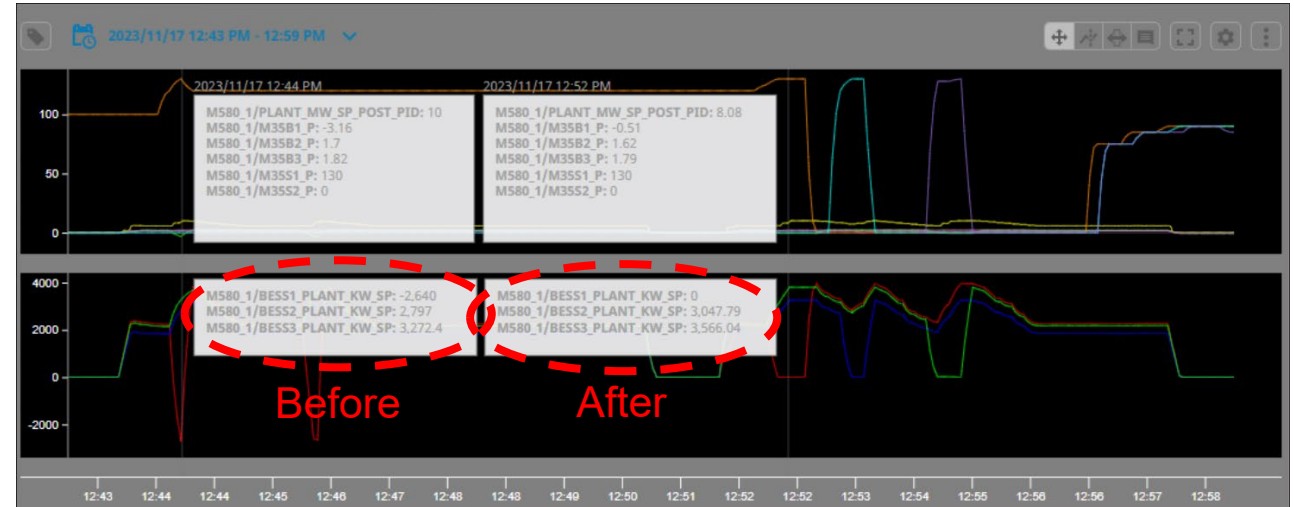
- Controller programming differences between GSUs revealed vulnerability in the code that translates site-level commands to inverter-level commands
 - When a GSU approached the specified MVA limit, it allowed for improper instructions to lineups to transition to discharge from charge (or vice-versa)
 - Testing confirmed disagreement of output that was consistent with behavior of GSU 3 during event

Differences in inverter-level setpoint command logic allowed inappropriate setpoints to be communicated to some inverters on site. The response of the remainder of the facility creates conditions for a sustained oscillation event.

- Updated GSU MVA protection logic to prevent MVA remaining value from going negative
- Corrected code inconsistencies for idle stop and inverter reset across site PLCs
- Standardized values for Ymin, Ymax, and automatic/manual transition across site PLCs

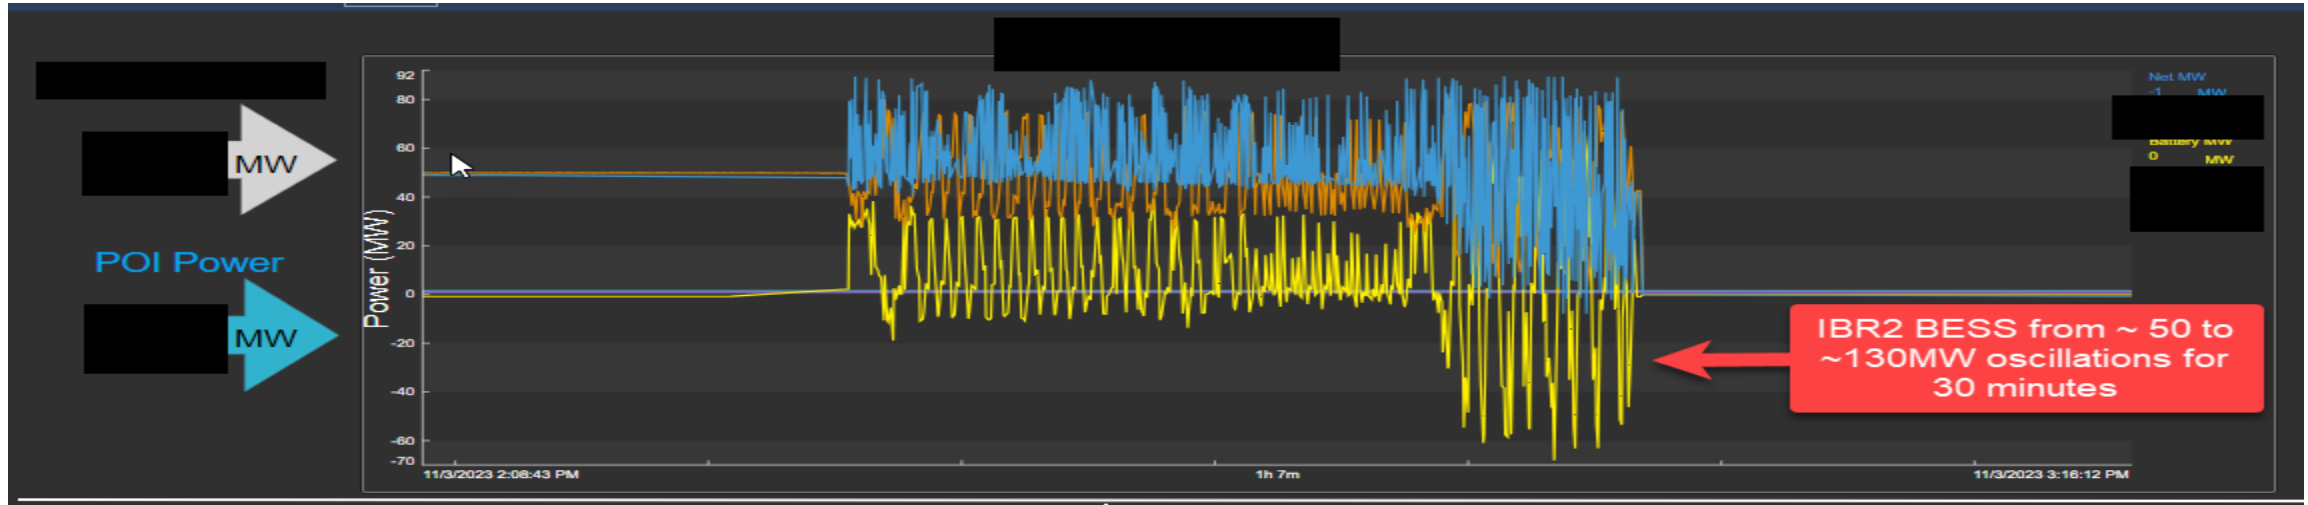
- **Event details:** SRP control room operators noticed the oscillation via PI Vision displays and called IBR Operator to address. SRP opened the POI breakers after a delay in response from the IBR Operator.

- **Cause:** Dual meter switching logic (BESS meter for charging and BESS+PV meter for discharging) aggravated by erroneous PV output signal test hard coded to 0MW instead of actual PV output.

- **WECC Impact:** Frequency of forced oscillations (0.25 Hz) was close to that of NS-A mode frequency causing the Modemeter to trigger alerts for NS-A mode critical damping ratio. Actual damping ratio remained unaffected. RC West and BPA ODM detected forced oscillations with low damping ratio alerts triggered in the RC West Modemeter for NS-A mode.

- **Solution:** Removed dual meter logic at all operator sites at SRP until more robust logic can be implemented. Improve operator process improvements for communicating and approving controller logic changes and testing to operator controls integrator and SRP. Improve operator control center oscillation detection logic and near term 24/7 SRP site monitoring personnel.

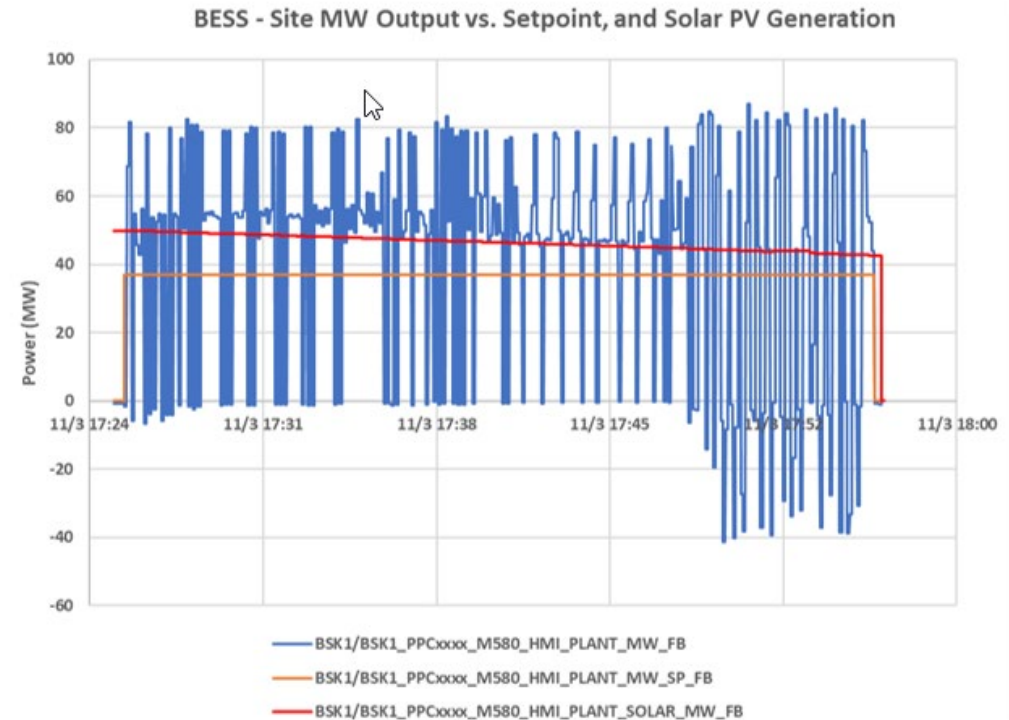
- Battery site was dispatched from a 0 MW setpoint to 37 MW discharge at ~17:25 EST on 11/3/2023
- Site output immediately began oscillating, with maximum output of ~85 MW and minimum of -40 MW
- Adjacent PV site under commissioning and was injecting ~50 MW at the time of event start

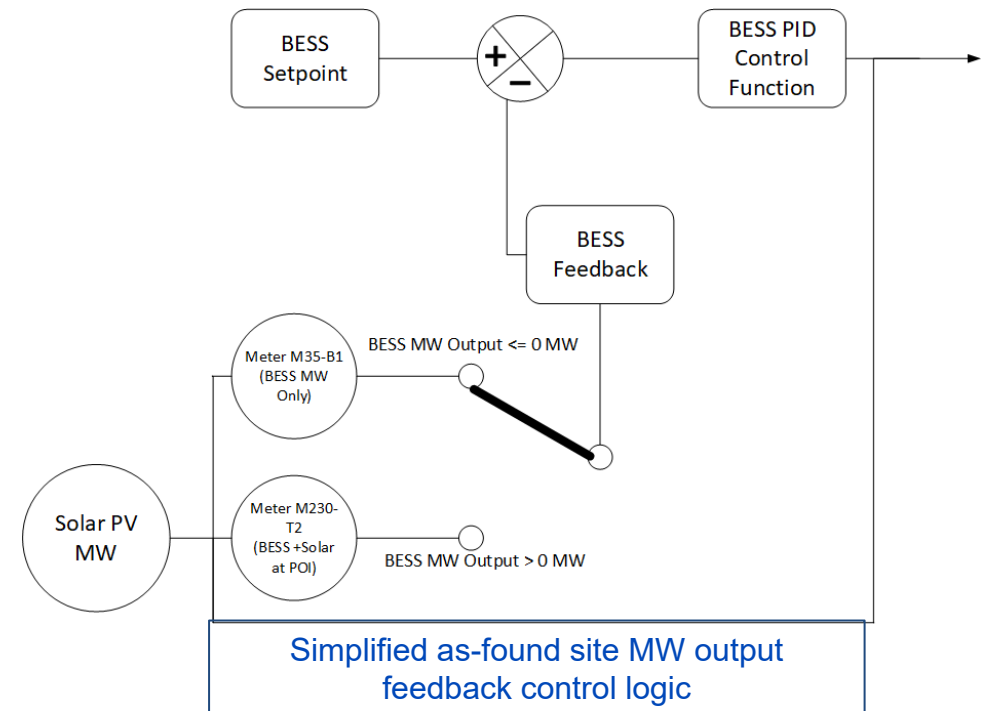
- Battery MW output value that is fed back to PID loop is dependent on if the site is charging or discharging
 - Discharging logic must include solar contribution to prevent interconnection limit violations
- Solar PV output was not yet added to metering scheme
 - Resulting in the controller misinterpreting the measured value as if the BESS site was exporting too much power when that meter source was selected

The dispatch period on 11/3 was the first instance of a BESS site command for a discharge value that was less than PV actual output

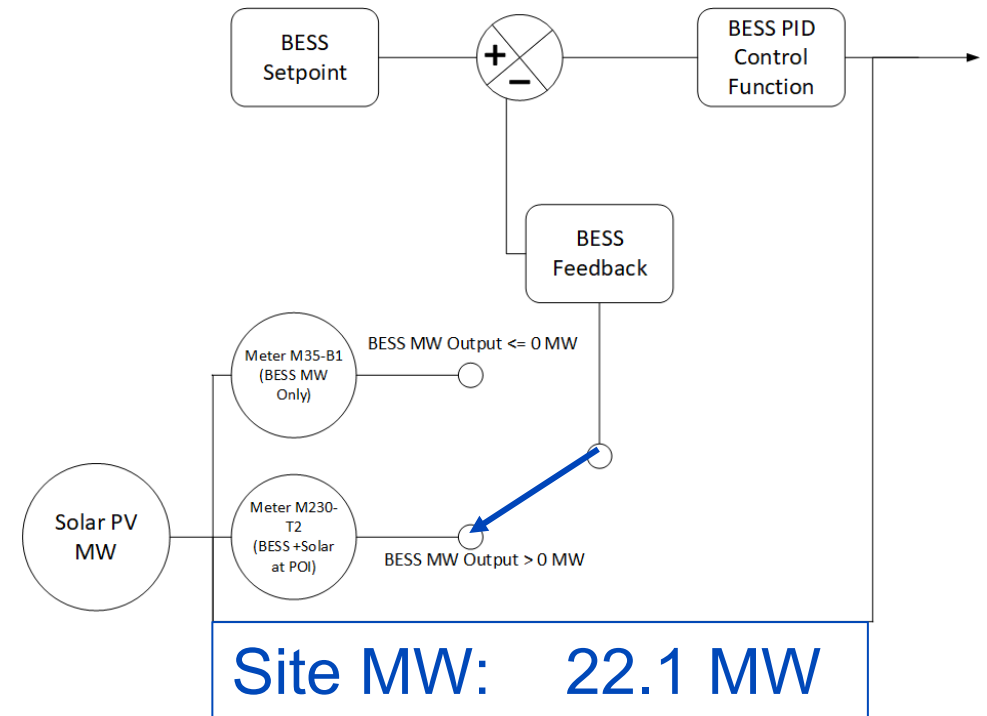
Battery site discharging against unachievable command

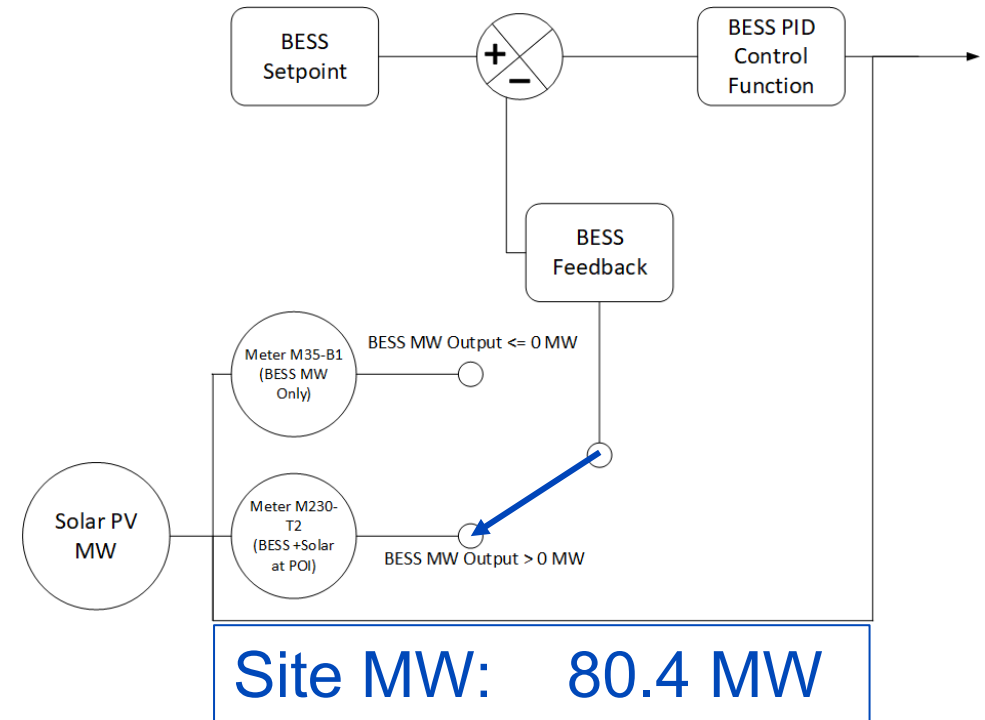
Battery instantly over-discharges, output control adjusts

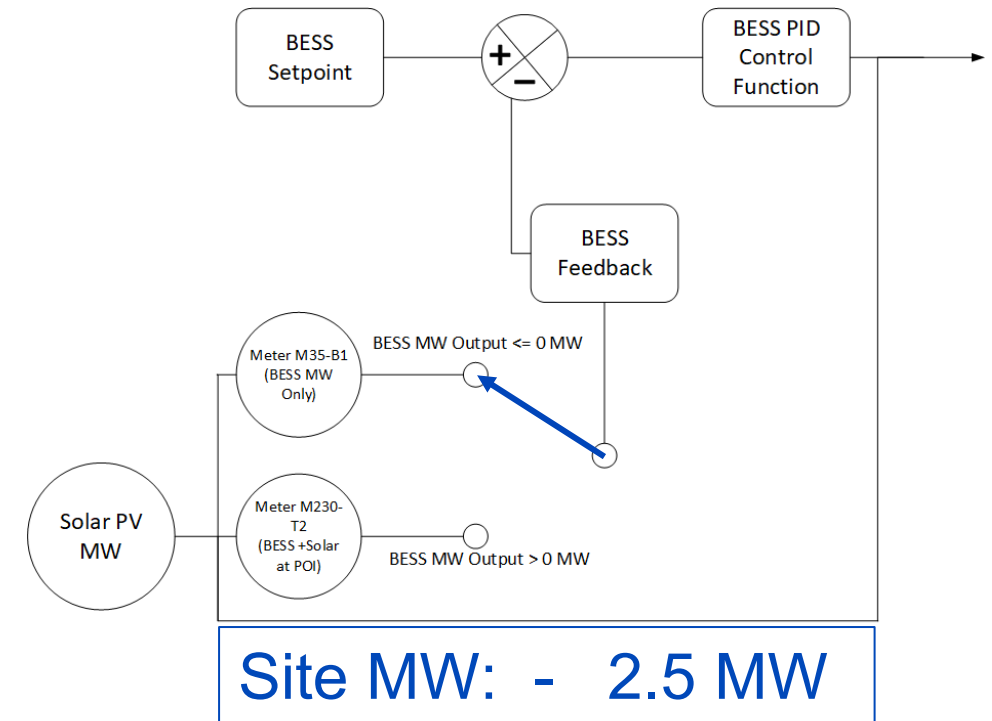
Battery output driven down to a charge condition, transitions back to alternate meter

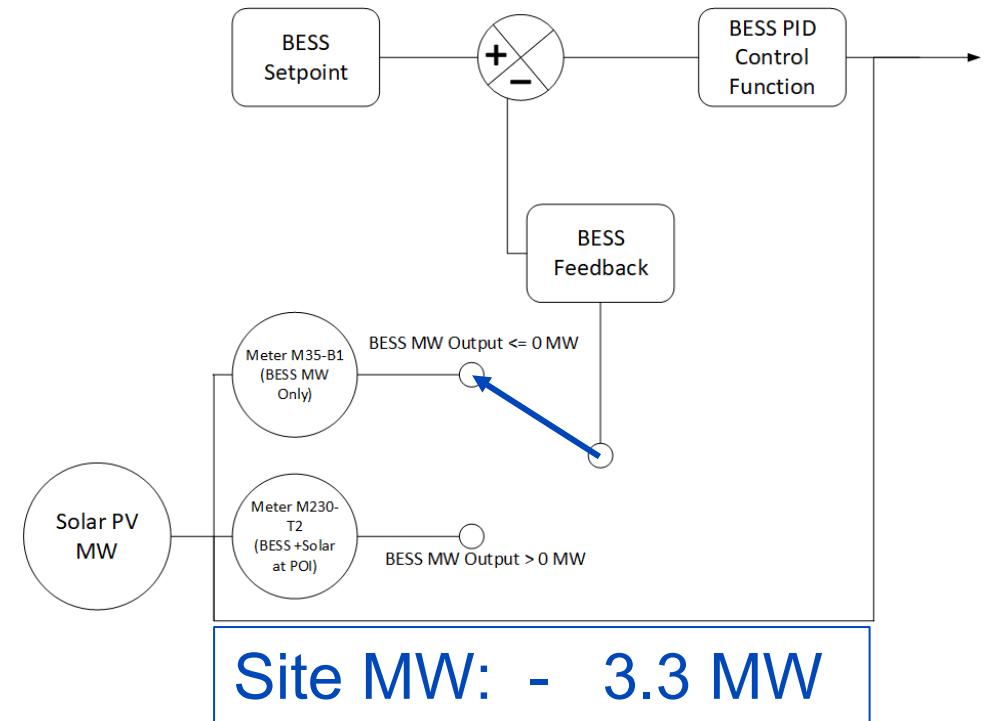
Battery output begins increasing output and will overshoot

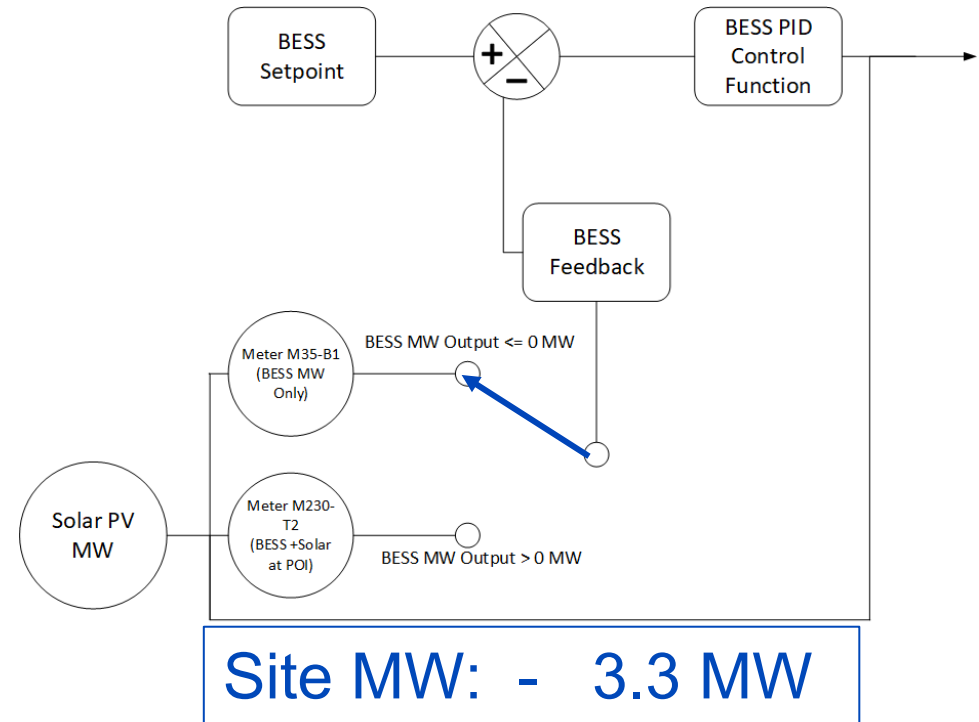
Oscillating MW response will continue until either site is stopped, or MW setpoint to battery is above solar output/below or equal to 0 MW
