California ISO | RC West

Model Validation Working Group MOD-33 Update

Licheng Jin
Operations Planning South, CAISO
05/22/2024

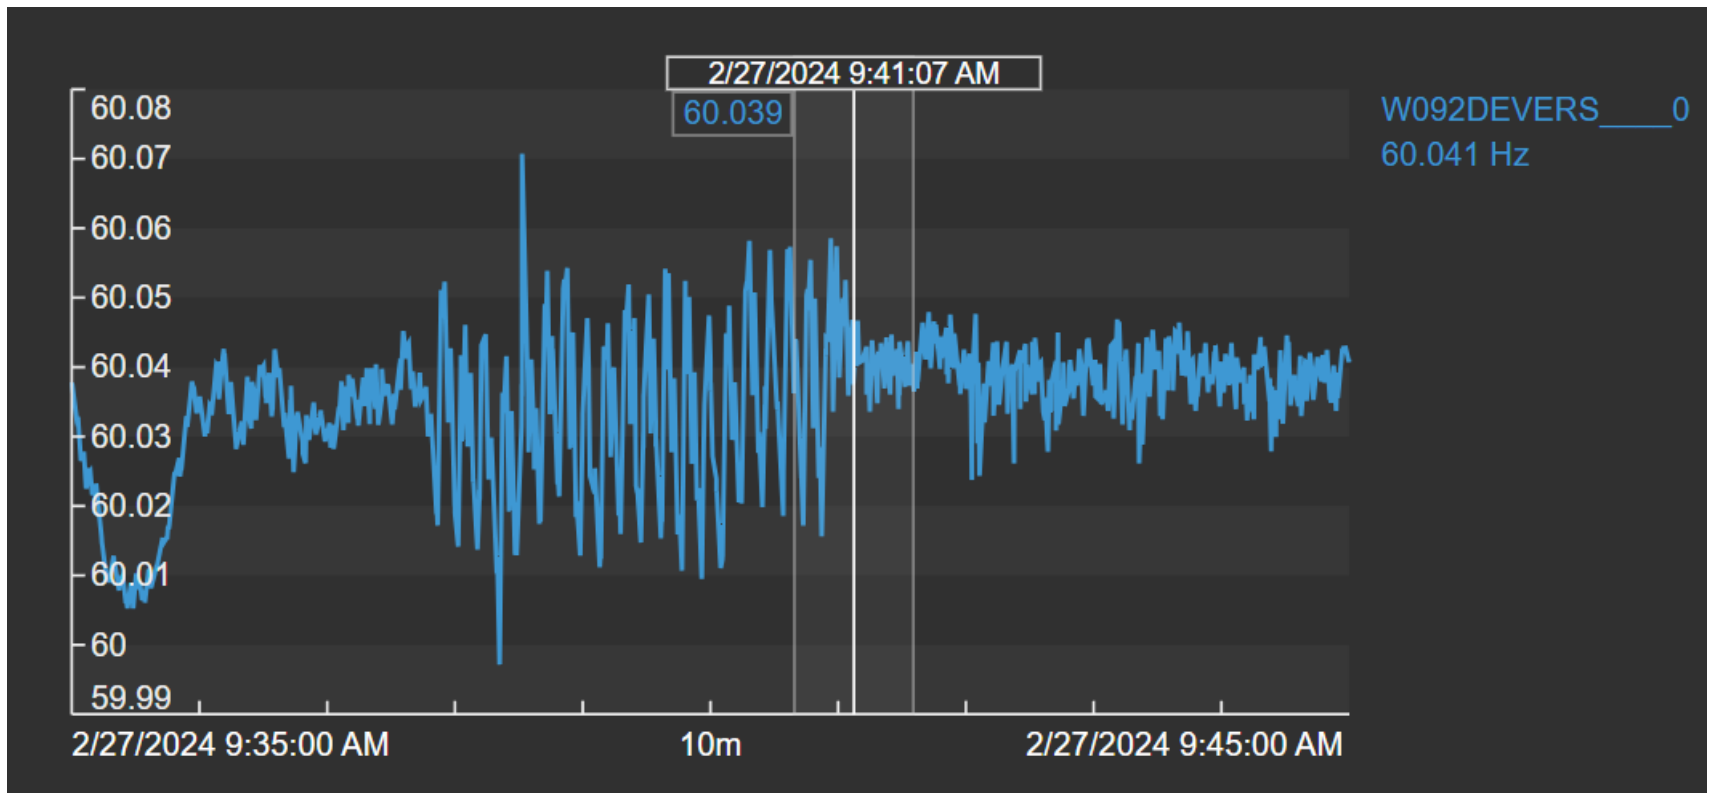
System Frequency

- BPA noticed an oscillation from 09:38-09:41 on 02/27/2024 along the N-S modes
- BPA inserted Fort Rock Series Comp at 0941 which likely mitigated the issue
- BCRC/BPA indicate >20% damping

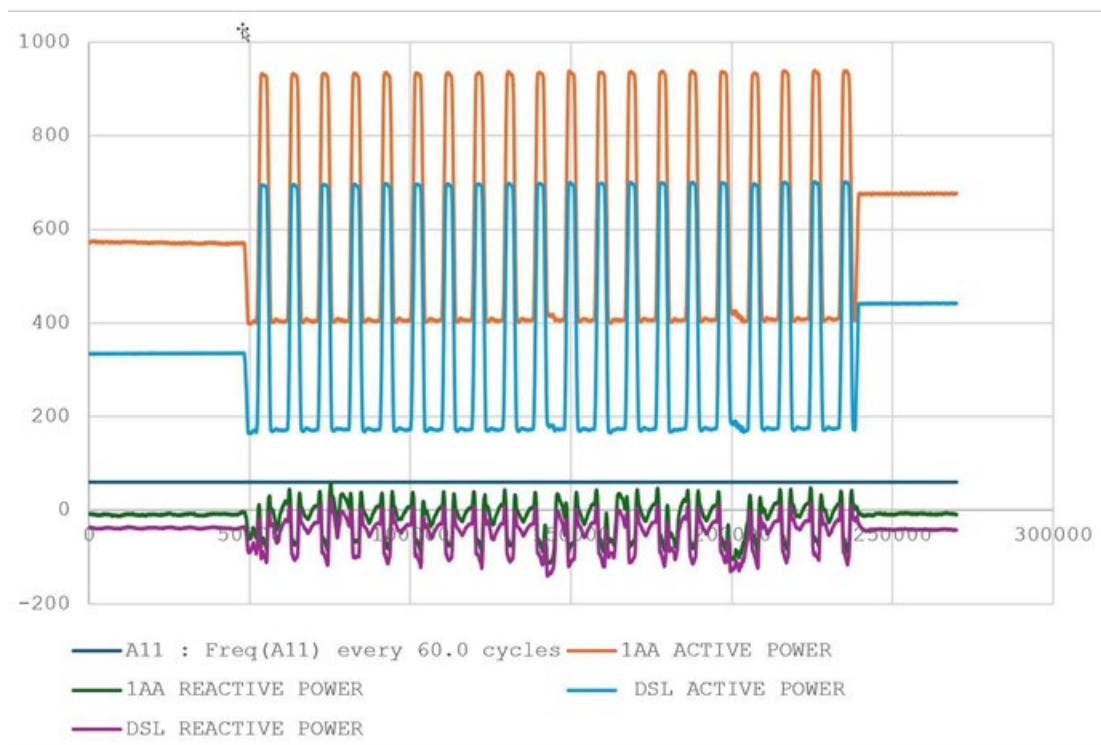
Fault Recording from SCE

- Real time telemetry problem at 07:00 AM PT was Observed at Desert Sunlight 1 BESS.
- The reboot of Desert Sunlight 1 BESS RIG triggered the power swing event.
- BESS site deviation between power setpoint (SP) and actual power charge and discharge feedback (FB)
- Incorrect BESS controls logic configuration amplified the deviation and initiated the high magnitude power swings

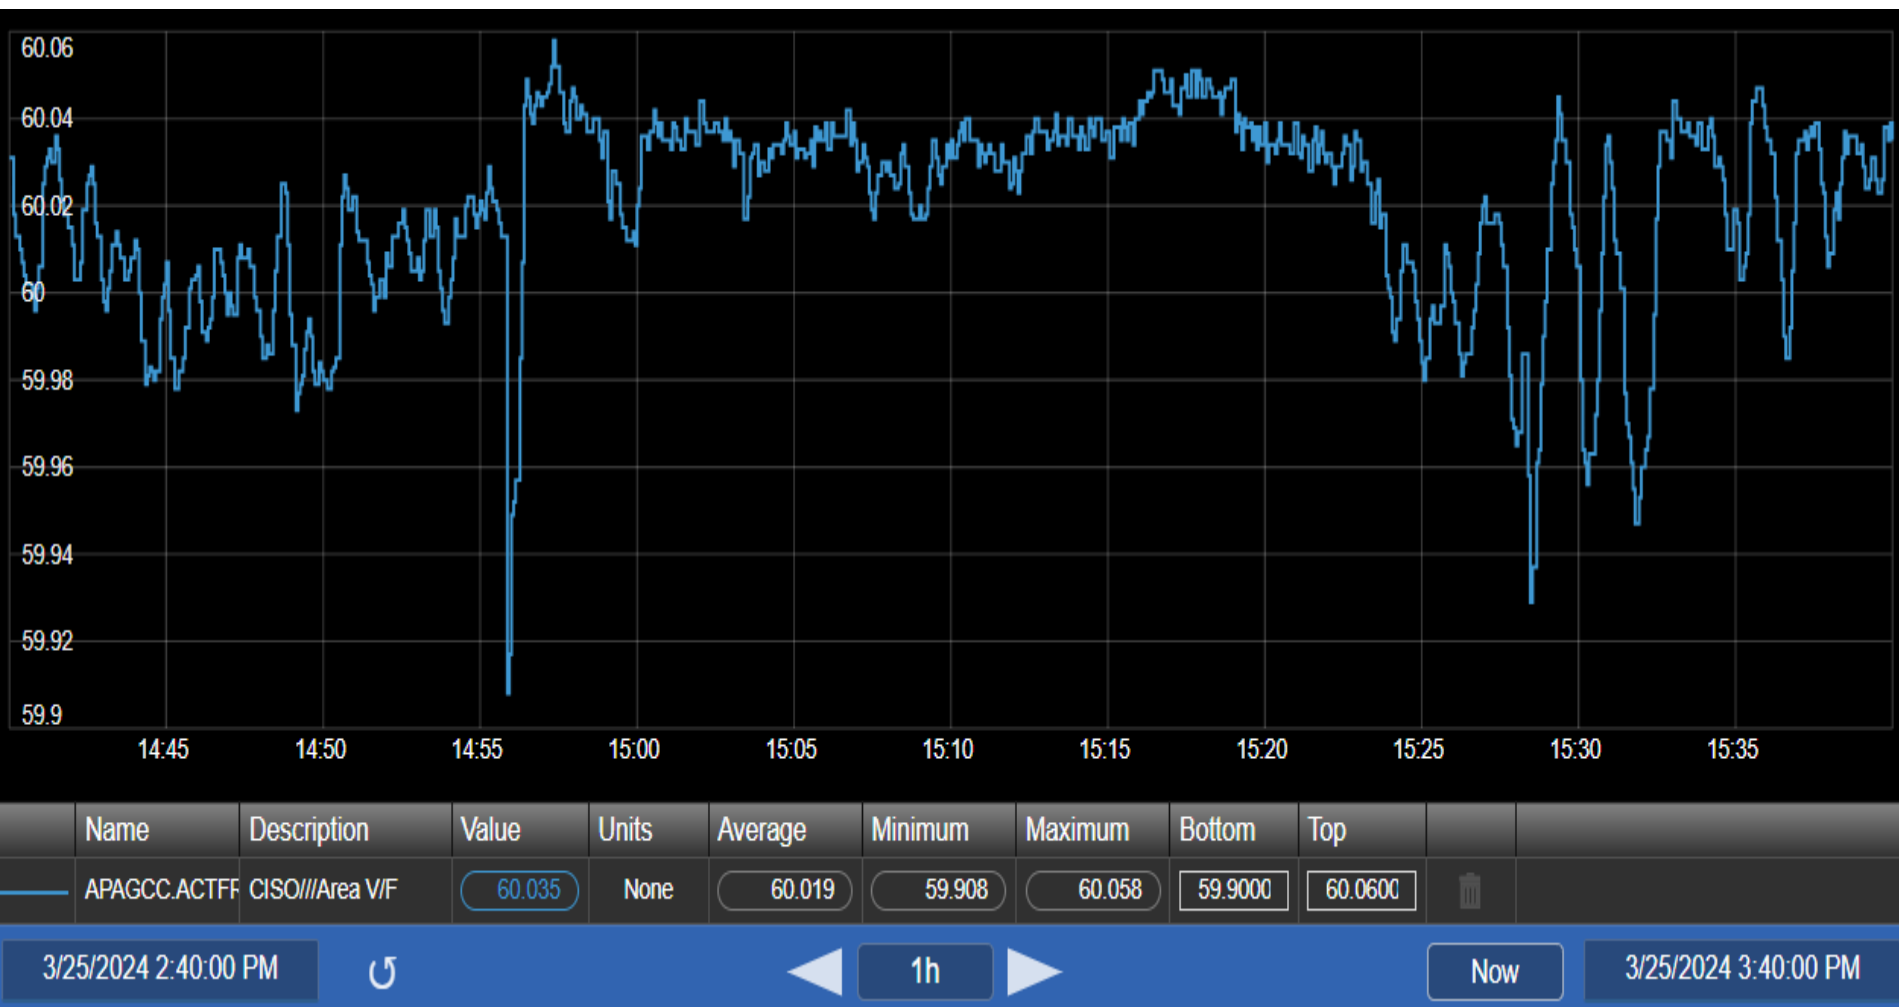
System Frequency

- 03252024 1455 The Vincent 500 kV South Bus and 500/230 kV 4AA Bank relayed OOS causing a loss of approximately 659 MW of solar generation from various resources. ACE went from a pre-disturbance value of 83 MW to a low of -1056 MW.
- At a time of 1528 PPT frequency deviated from 59.986 Hz to a minimum of 59.929 Hz. Due to large ACE swings in CA area.
- 1528 PACE Jim Bridger 2 tripped offline rejecting 170 MW. ETR and cause unknown.
- 1542 CAISO has changed/modified the AGC control bands in an attempt to mitigate the large ACE control swings happening for the last 15-20 minutes. Some of the battery resources on AGC were hunting and the revised AGC control bands stopped it.
