A Bus Cleared and a Hidden Breaker Insulation Failure Revealed

Robert Roman and Kevin Damron
Avista Utilities

Emma Clawson
Schweitzer Engineering Laboratories, Inc.

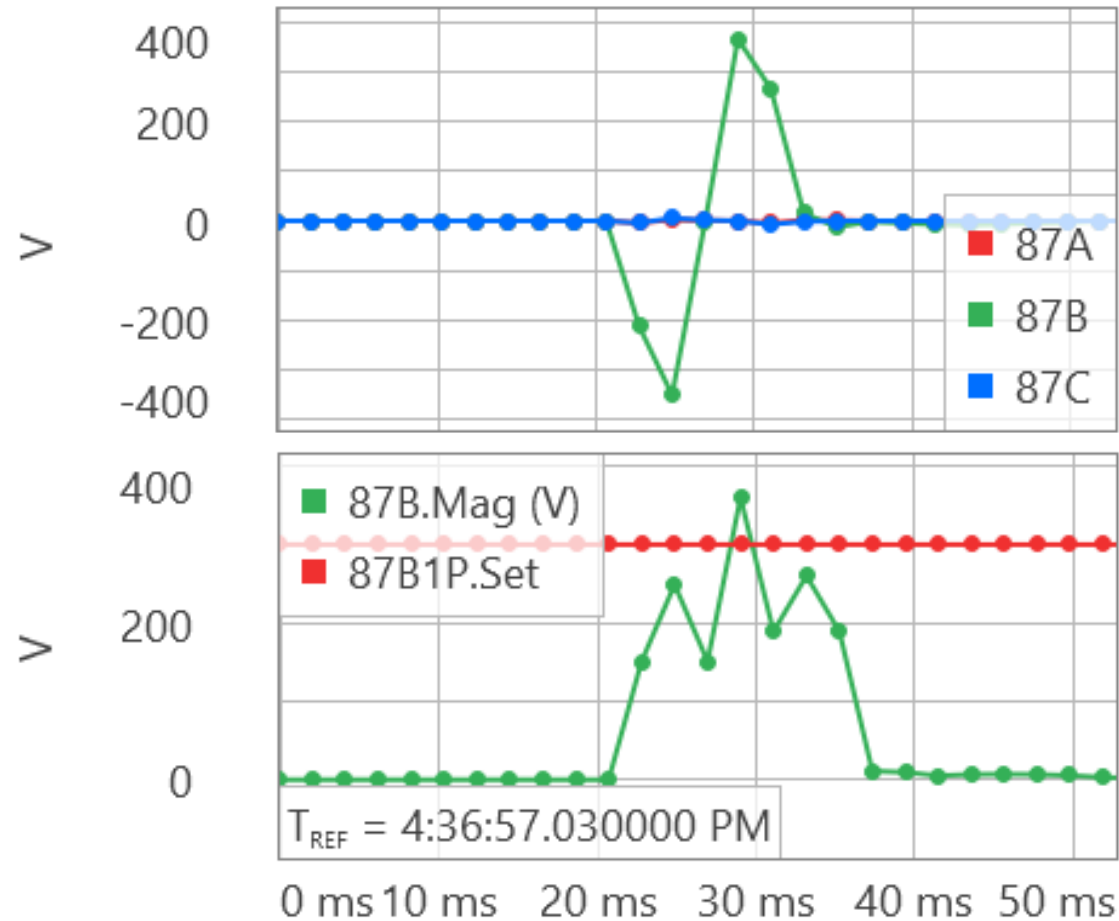
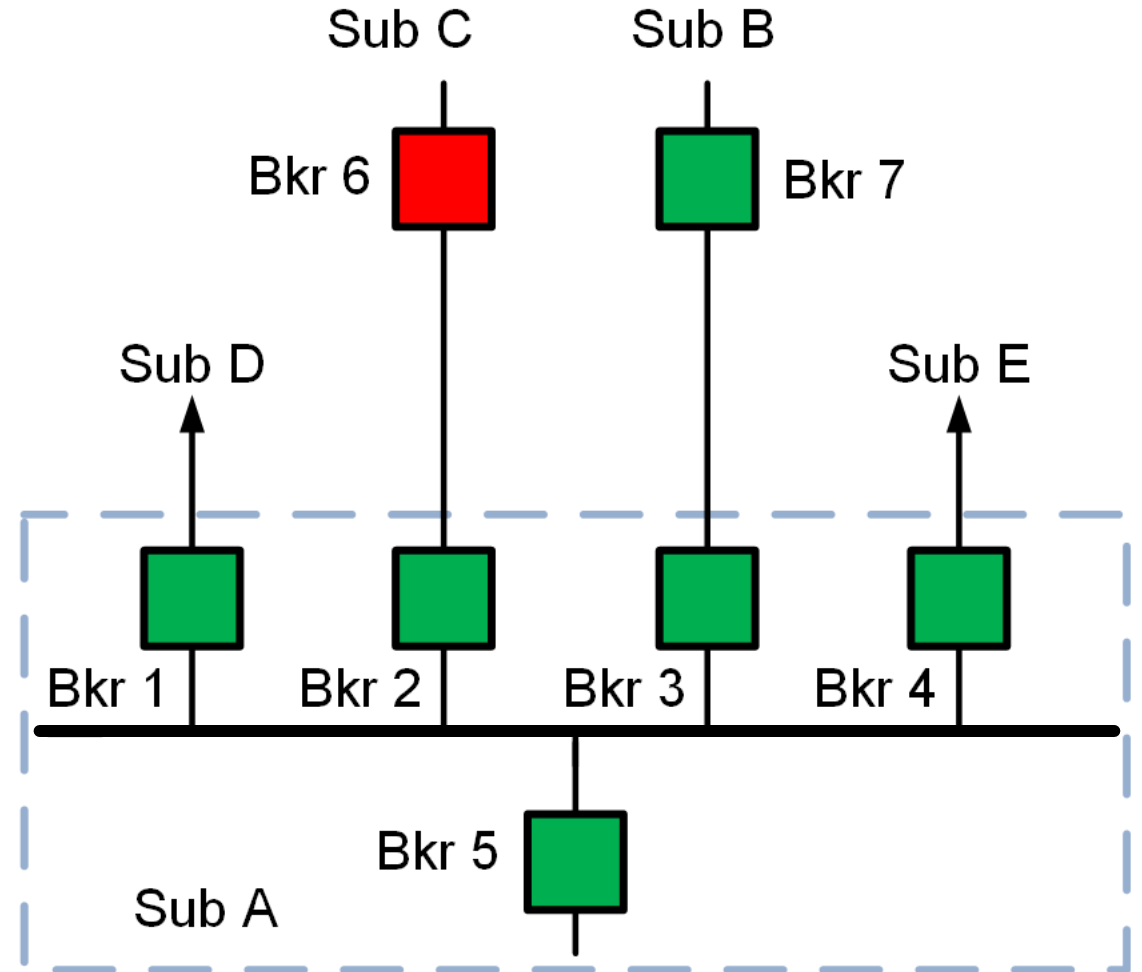
High-impedance bus differential relay trips Sub A bus

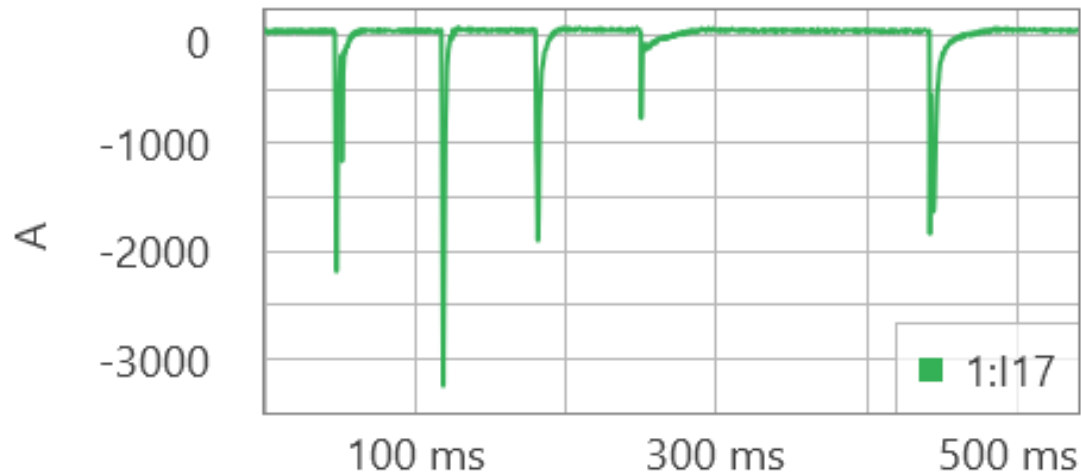
Lightning strike report

- Initial BG fault 16:37:00.5165
- 5 high-frequency current transients 16:37:00.946 to 16:37:01.400

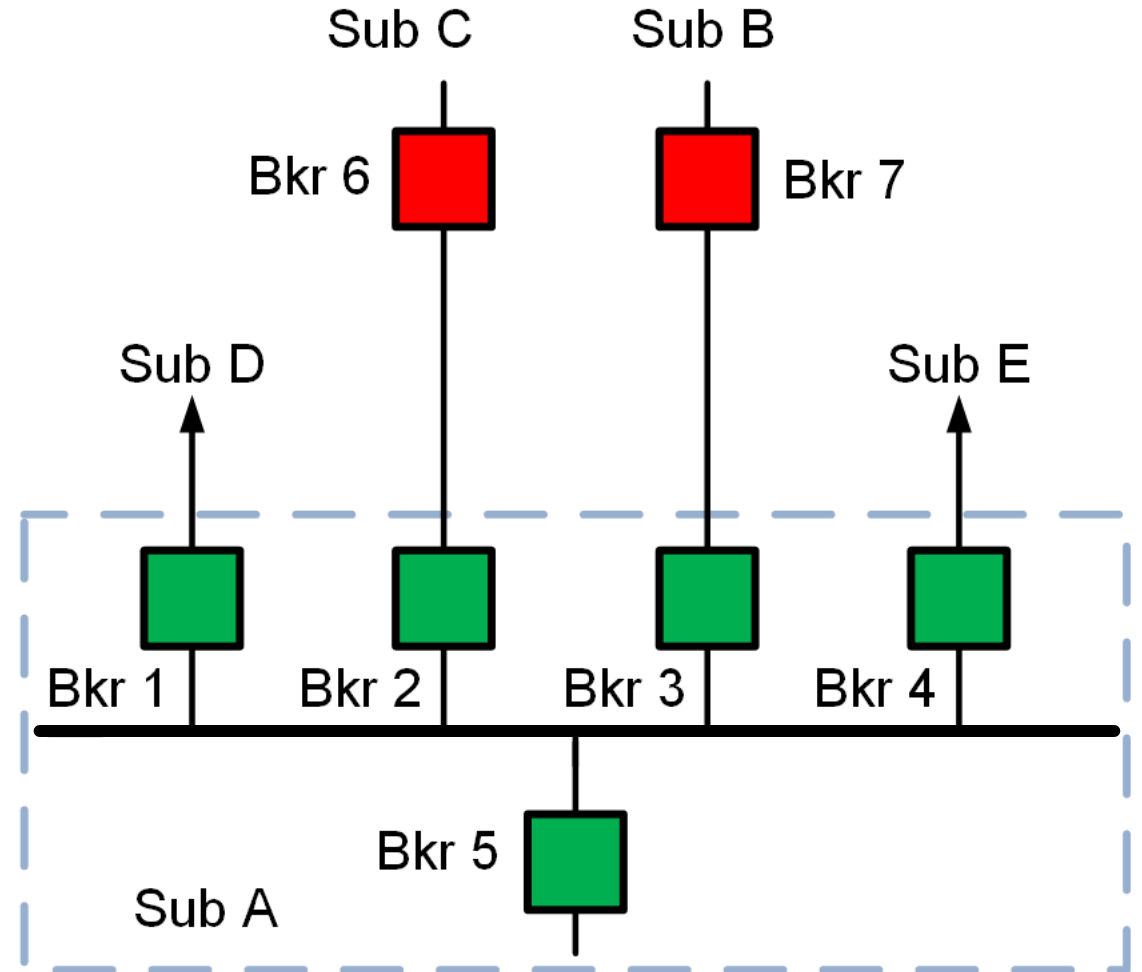
Sub B Bkr 7 recloses successfully

- 1 second after initial BG fault, Sub B Bkr 7 recloses
- Sub B supplies 42 A charging current
- Bkr 3 is able to withstand nominal voltage

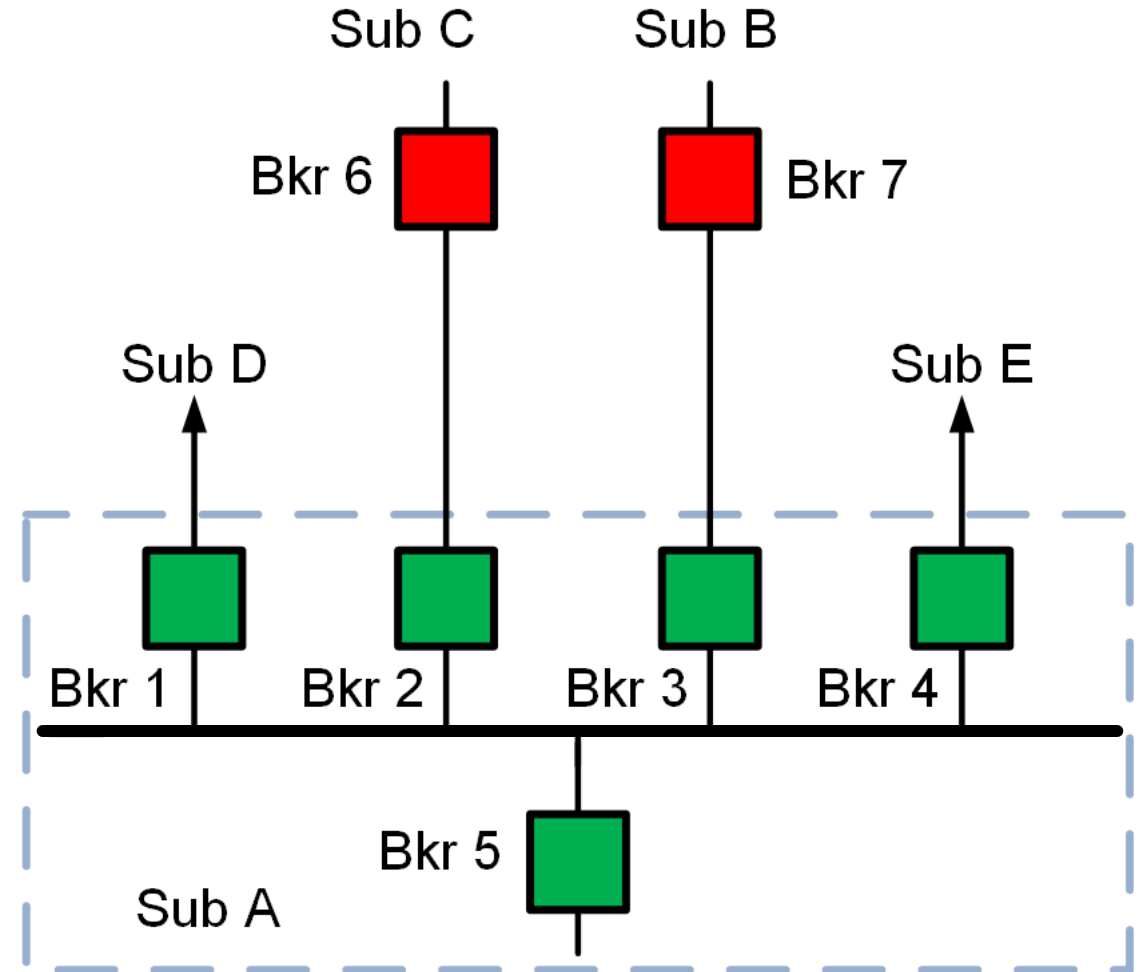
Sub A tripped again by 87B2 relay

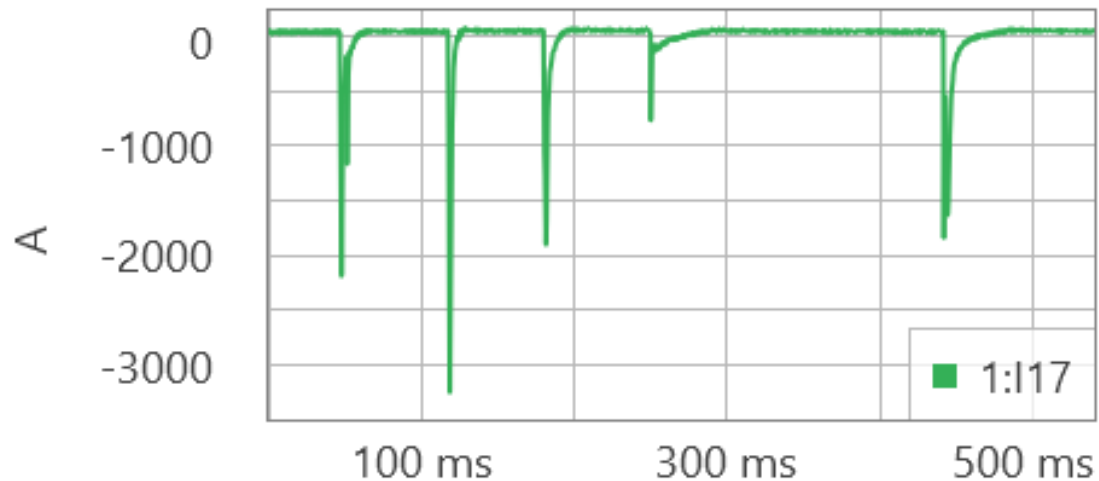
- Initial Sub A–Sub B line BG fault occurred
- Bkr 3 internal flashover (caused Sub A bus to be cleared)
- Bkr 2 internal flashover (fault occurred)

- Gas sample was normal
- No damage was visible

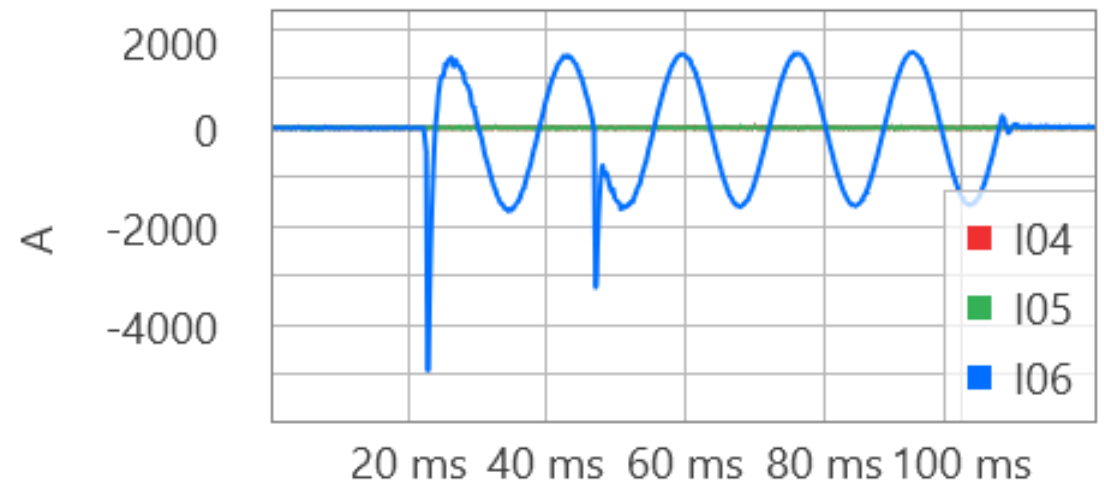
Bkr 2

- Gas sample indicated problem
- Arcing marks were visible
- Breaker sustained 1,062 A rms fault current

- Preventative actions
 - Add shield wires
 - Add surge arrestors at 230 kV level
- Benefit of multiple operating principles
- Depth of event analysis
 - Low- and high-resolution relay event reports
 - Lightning strike reports
