# **Inverter-Based Resource Disturbances in the Western Interconnection**

CAISO, NERC, and WECC Staff Report

October 2025

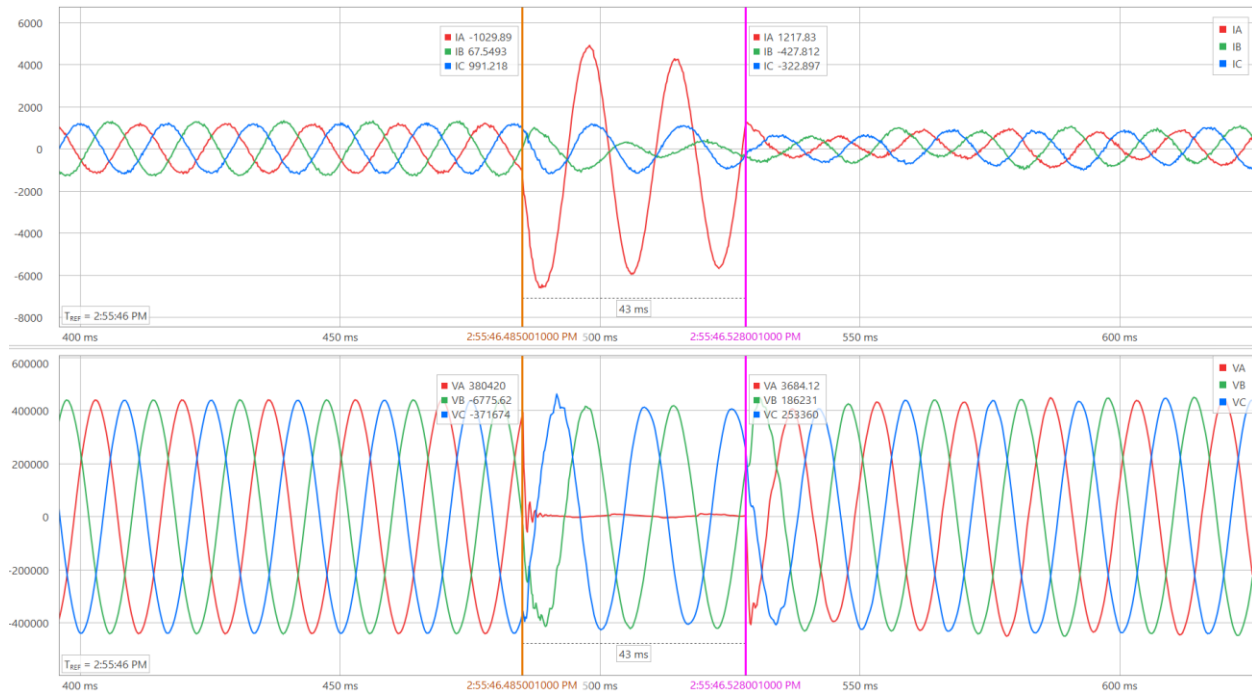
Figure 3: Fault clearing for March 25 disturbance.

**March 25, 2024 “Vincent Disturbance”:** At 14:55:52, the Vincent 500kV South bus, along with 3AA and 4AA banks, relayed during restoration of a power circuit breaker after scheduled maintenance at Vincent. CAISO observed a 1,046 MW reduction in solar PV and wind resources across the area. CAISO identified 28 facilities that reduced output due to the fault.

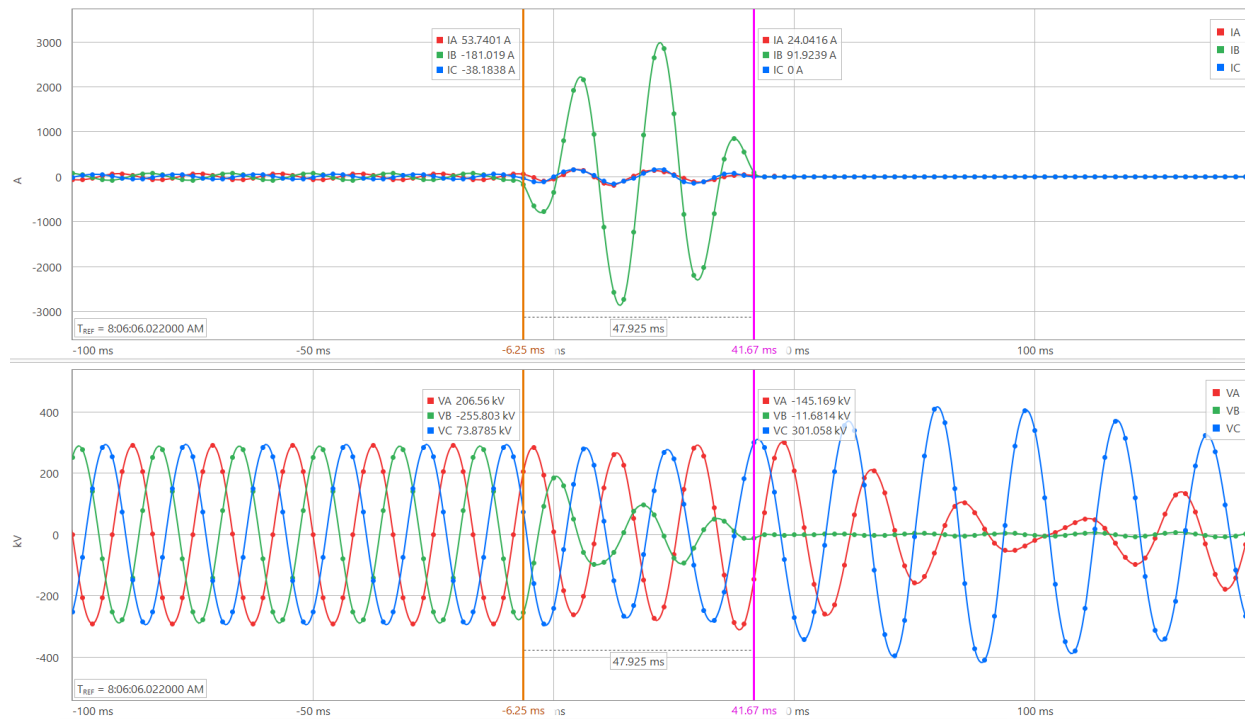
Figure 4: Fault clearing for May 12 disturbance.

**May 12, 2024 “Red Butte Disturbance”:** At 07:06 the Hickory-Red Butte 345kV line relayed out on a phase-to-phase fault. PACE observed a 532 MW reduction in solar PV resources across the area. PACE identified eight solar PV facilities that reduced output due to the fault.

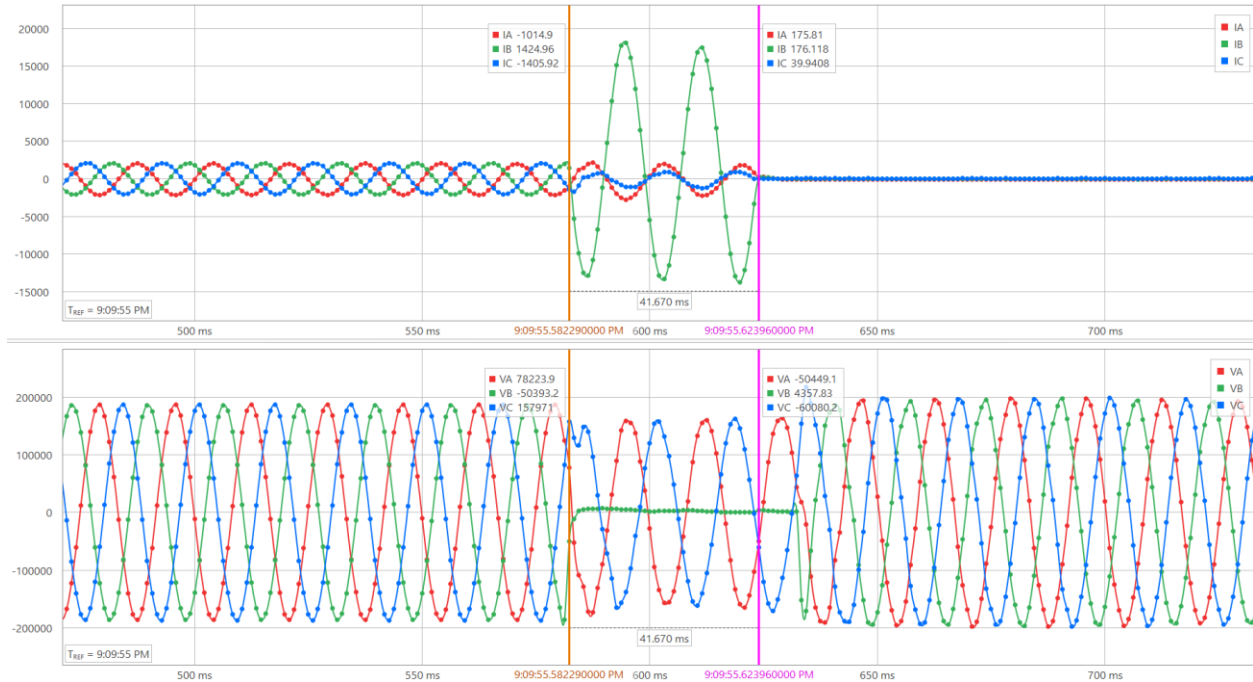
Figure 5: Fault clearing for May 20 disturbance.

**May 20, 2024 “Windhub Disturbance”:** At 21:10:04, the Windhub 500/230 kV 3AA transformer bank tripped on differential protection when a riser lead became separated. CAISO observed a 698 MW reduction in solar PV, wind, and BESS resources. Due to the event time, the majority loss was wind and BESS for this incident. CAISO identified 22 facilities that reduced output due to the fault.

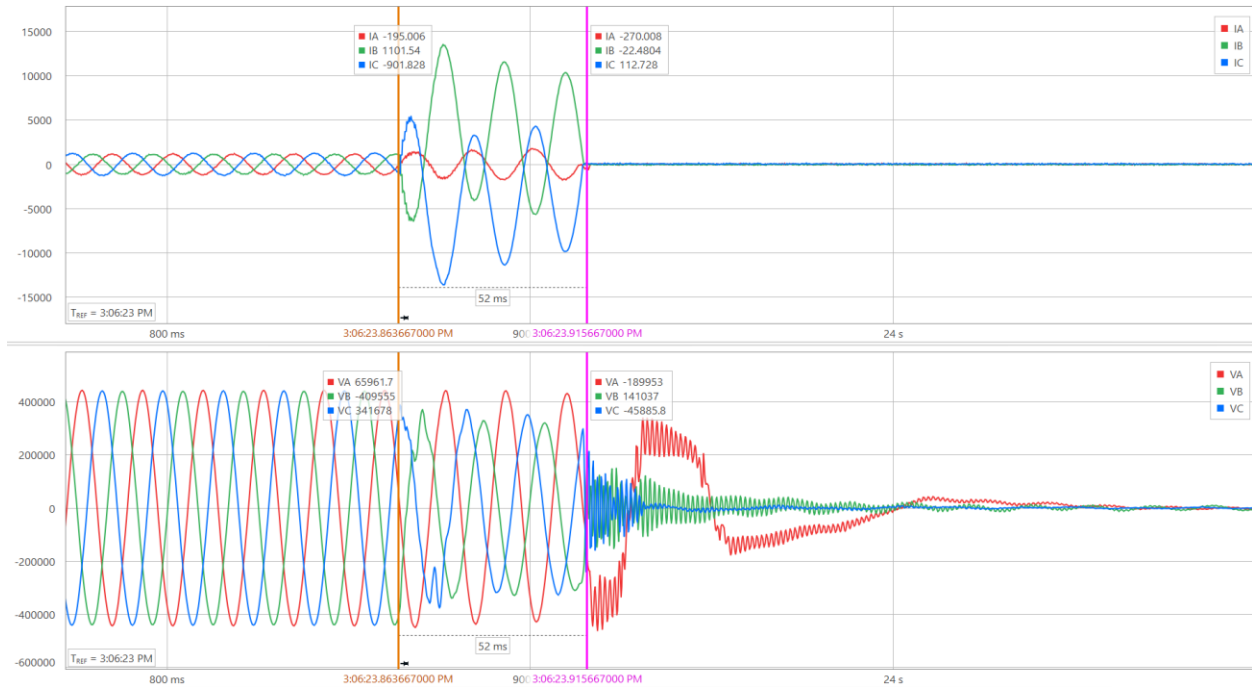
Figure 6: Fault clearing for June 15 disturbance

**June 15, 2024 “Post Fire Disturbance”:** At 15:06:40, the Post fire burning near the Midway-Vincent corridor resulted in the trip of the Midway-Vincent #1 500kV line. CAISO observed a 934 MW reduction in solar PV, wind, and BESS resources. At 15:07, the Midway-Vincent #2 500kV line also tripped. The lines remained out of service until the fire burned clear of the corridor. CAISO identified 37 facilities that reduced output due to the fault.

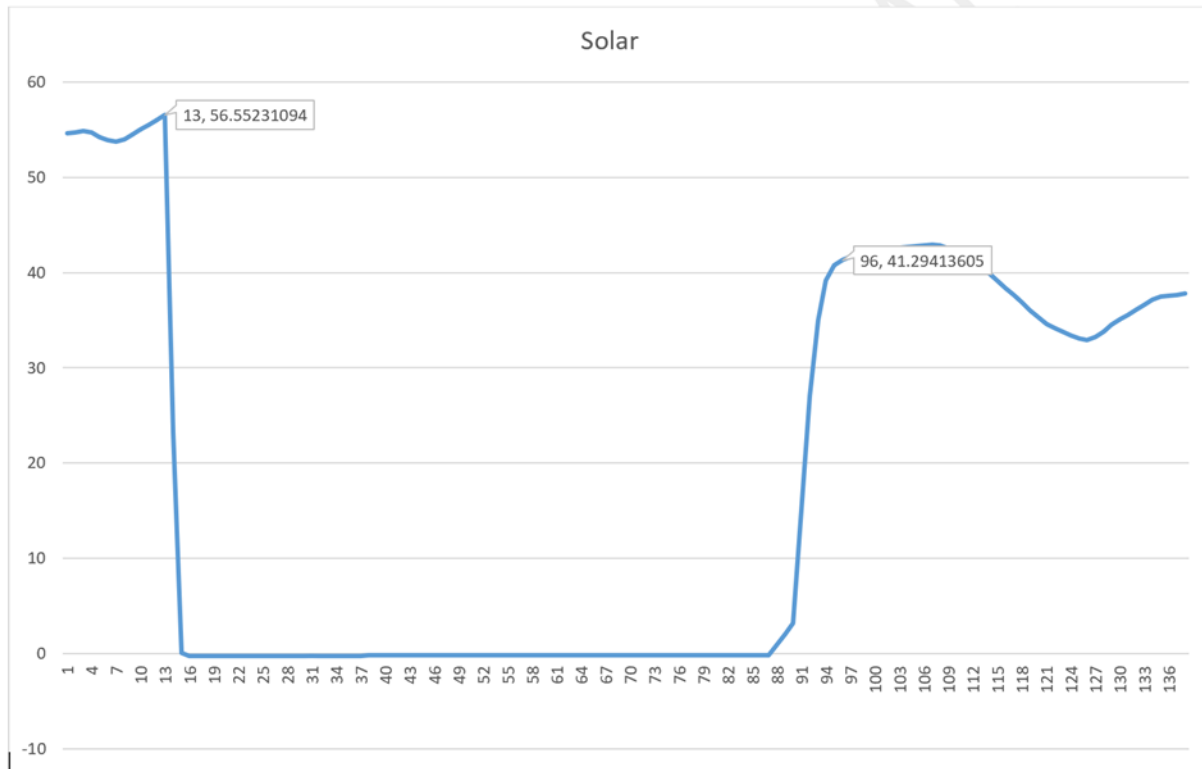
Figure 8: Sample reduction data

Drop: 56MW, duration of cessation was recorded as 5 minutes.
