# **Air Conditioner Test Report**

**November 27, 2006**

# Air Conditioner Stalling Effects Study

## Air Conditioner Test Report

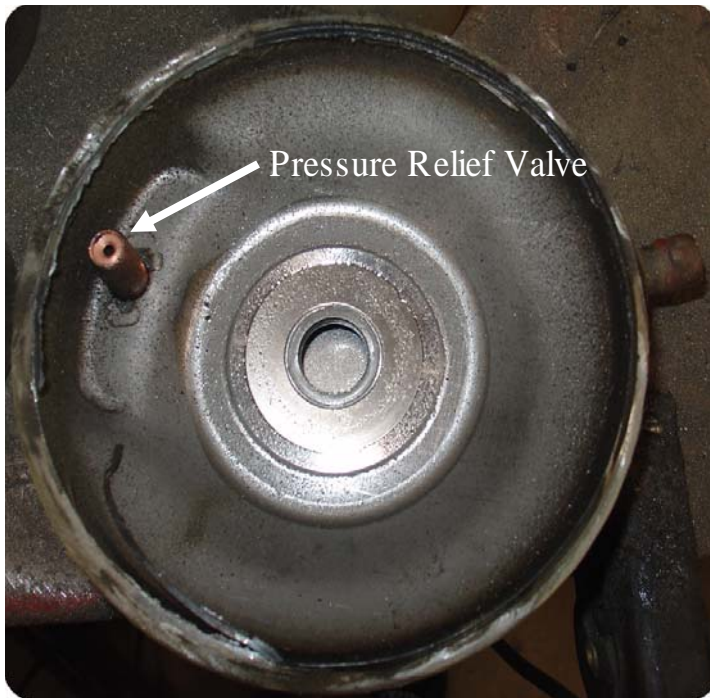
**Graph 3** – Pressure Relief Valve

Most of the tested air conditioner units with scroll compressors went into IDLE (drawing the same running amps without producing any cooling) or NO-LOAD (drawing about ½ the running amps without producing any cooling) condition after a *circuit breaker clearing* generated type of transient. It seems that some mechanical device prevented them from restarting normally. We opened a scroll compressor and found a pressure relief valve between the high pressure and low-pressure chambers.

This valve is designed to prevent too much pressure from building up in the high-pressure side, releasing it into the low-pressure chamber. This valve may have stuck open when the compressor went into either IDLE or NO-LOAD condition because the unit draws current but no pressure is built up, and no cooling is produced. The air conditioner unit had to be turned off and then back on again to resume normal running condition.
