Moss Landing BESS Fire Report
Operations Analysis
December 2025

This report provides insights into the January 16, 2025 fire affecting Phase 1 of the Moss Landing BESS facility in California, along with key findings from other BESS fire events. Moss Landing was one of the earliest large-scale BESS installations, and it was constructed before the release of NFPA 855, the first fire safety standard for energy storage systems. The incident also underscores the importance of evolving design standards.

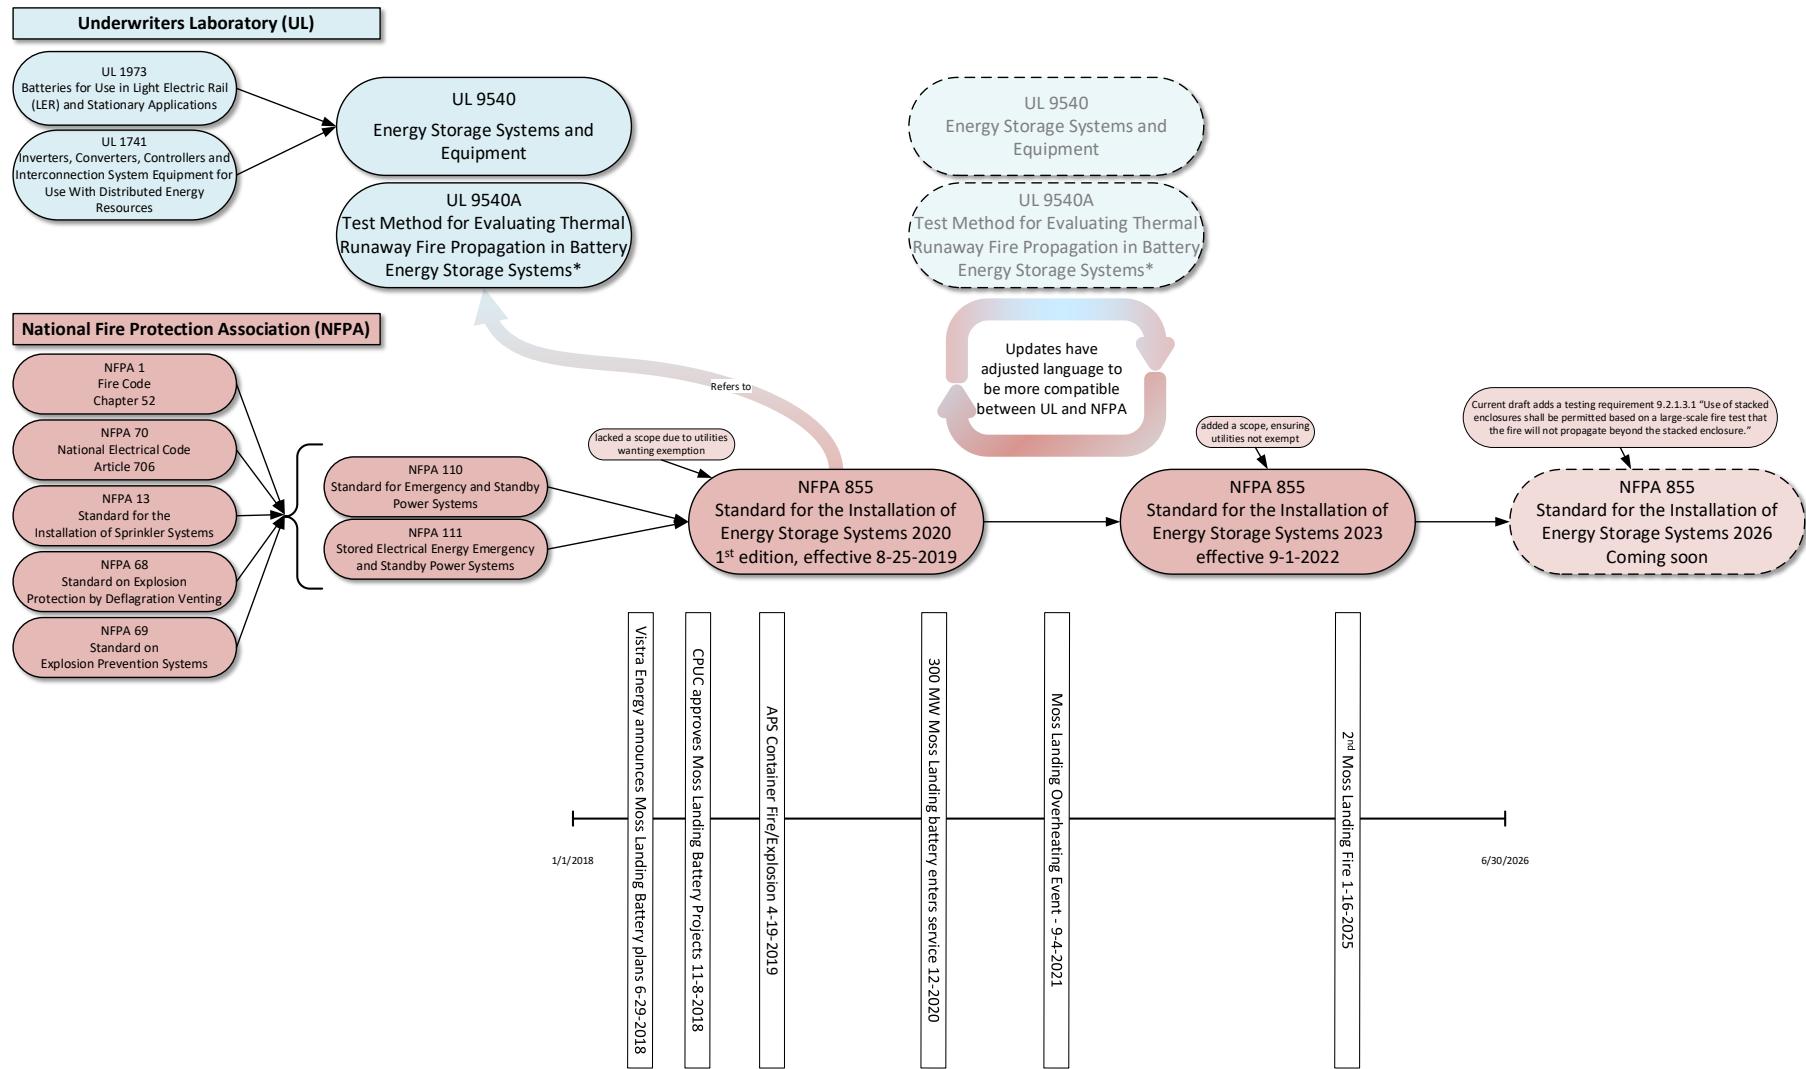
The main fire codes discussed here are from UL and the NFPA. The diagram below describes the establishment of codes and standards related to BESS, along with a timeline of key dates for ML300.

The design of ML 300 was complete and accepted before NFPA 855 2020 being issued. UL 9540 pre-existed (initially released in 2016) the design of Moss Landing and was applicable, and the racks used for ML 300 were UL 9540a tested and certified.

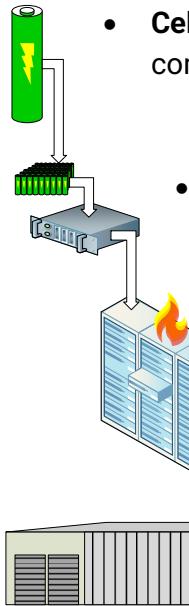
UL 9540A contains four testing levels for thermal runaway propagation in energy storage systems (ESS):

- **Cell-level test:** Evaluates the thermal runaway characteristics of the cell as well as the composition and flammability of the gases
- **Module-level test:** Evaluates the tendency of cell thermal runaway propagation, the heat and gas release rate of the module, and the potential danger of ignition or deflagration
- **Unit-level test:** Evaluates the likelihood of fire spread between modules, the unit's heat and gas release rates, and the potential for deflagration or re-ignition
- **Installation-level test:** Evaluates the effectiveness of the fire protection system, as well as the heat and gas release rate of the system, and the danger of deflagration or re-ignition
