SRP IBR Oscillation Event Report for 9/20/23, 11/1/23 and 11/3/23 Events

September 20, 2023 IBR1 BESS Oscillation Summary

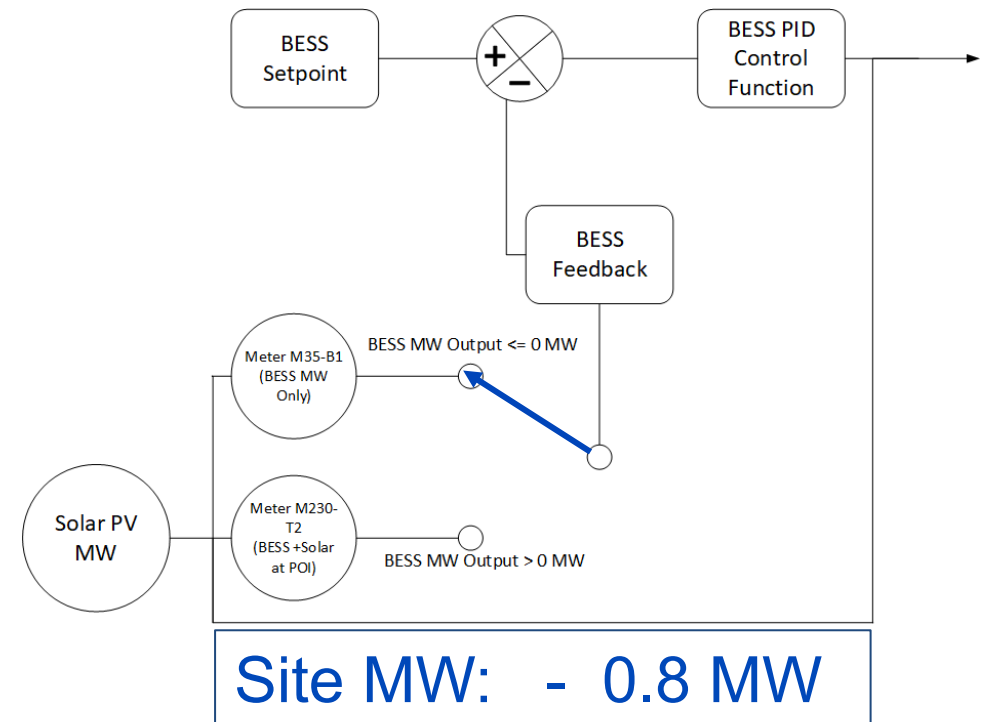
Sequence of Mis-operation

- Battery idle w/ ~ -0.8 M of auxiliary load
- Setpoint of 37 MW received
- BESS inverters wake and export power
- BESS output now positive, switch to alternate meter scheme
- PID sees battery MW too high, instruct rapid reduction of output
- Site MW goes negative, swaps meter scheme
- PID sees battery MW too low, instruct rapid increase in output
- Cycle repeats until shutdown

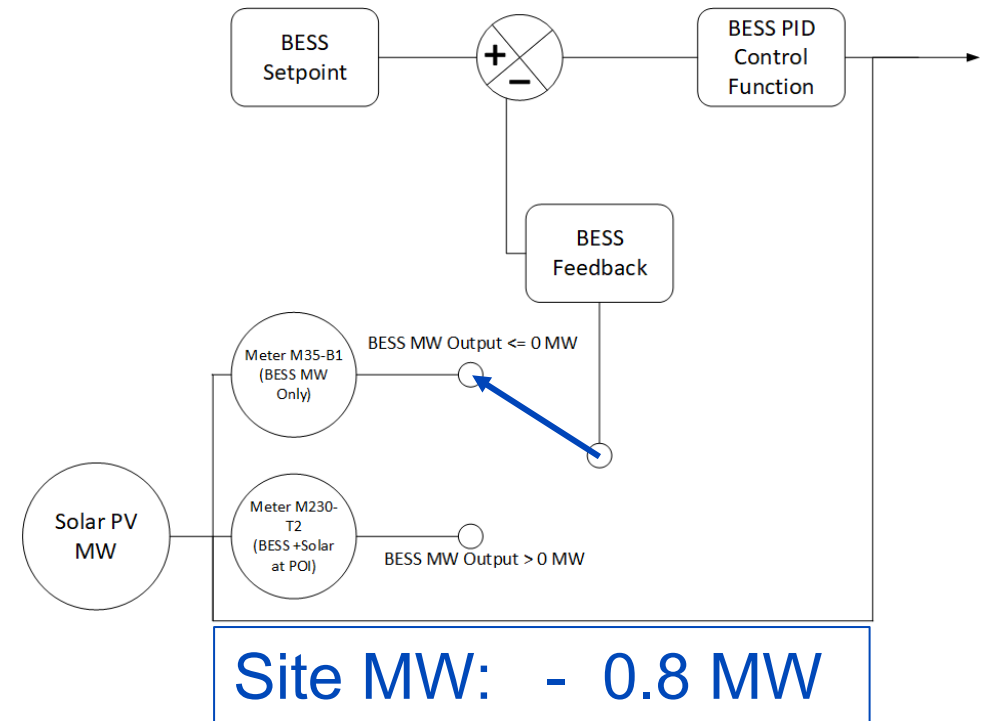
Sequence of Mis-operation

- Battery idle w/ ~ -0.8 M of auxiliary load
- ➔ • Setpoint of 37 MW received
- BESS inverters wake and export power
- BESS output now positive, switch to alternate meter scheme
- PID sees battery MW too high, instruct rapid reduction of output
- Site MW goes negative, swaps meter scheme
- PID sees battery MW too low, instruct rapid increase in output
- Cycle repeats until shutdown

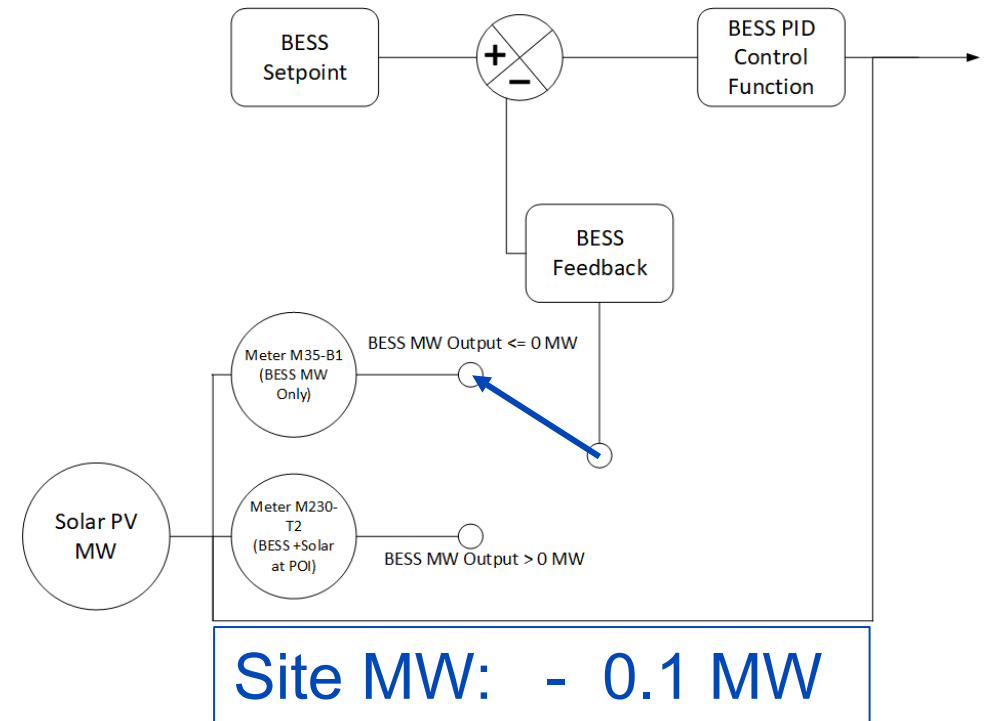
Sequence of Mis-operation

- Battery idle w/ ~ -0.8 M of auxiliary load
- Setpoint of 37 MW received
- ➔ • BESS inverters wake and export power
- BESS output now positive, switch to alternate meter scheme
- PID sees battery MW too high, instruct rapid reduction of output
- Site MW goes negative, swaps meter scheme
- PID sees battery MW too low, instruct rapid increase in output
- Cycle repeats until shutdown
