## **2021 Misoperation Report**

Relay Work Group

September 28, 2022

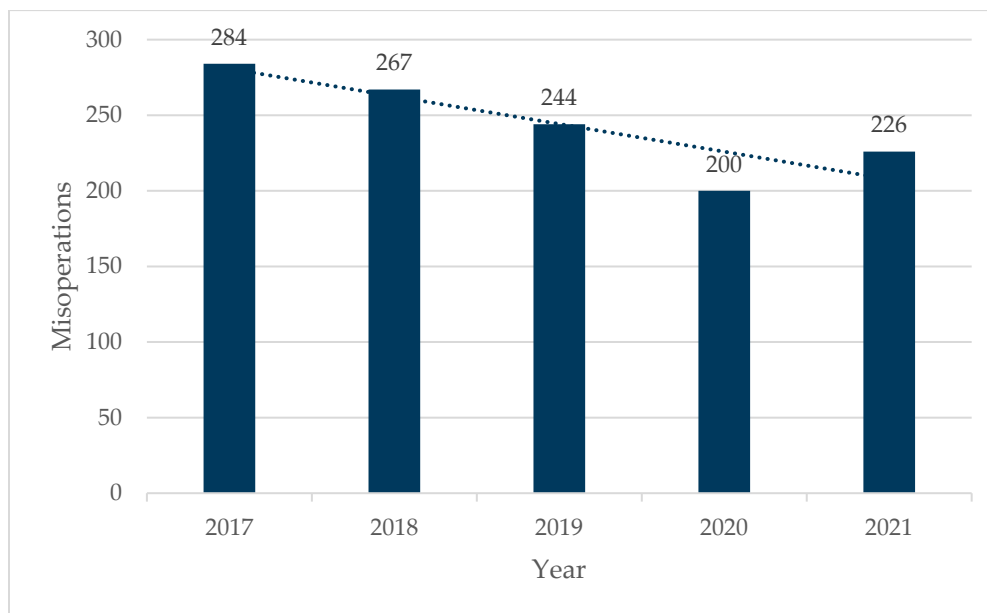
**Figure 1: Western Interconnection Total Misoperations 2017 to 2021 trend**

For the Western Interconnection, the total number of yearly misoperations has continued to trend downward. The trend of misoperations from 2017 to 2021 for the Western Interconnection is shown in Figure 1. The Western Interconnection misoperation rate has a slight downward trend, also shown in Figure 2.

The trending of 2017 through 2021 indicates that the total misoperations has had a slight downward trend over the past five years—284, 267, 244, 200, and 226—though, the total increased slightly between 2020 and 2021. “Incorrect setting/logic/design errors” is still the leading cause of misoperations within the Western Interconnection. The RWG believes the majority of misoperations due to setting errors are preventable. Best practices to avoid settings errors include using peer reviews, proving increased training, performing more extensive fault studies, and standardizing protection scheme design/logic templates for microprocessor relays. A periodic review of the existing settings in the installed relay fleet can also reduce misoperations caused by a change in system topography. NERC PRC-027 has requirements for periodic reviews and is intended to reduce the number of misoperations in the future.

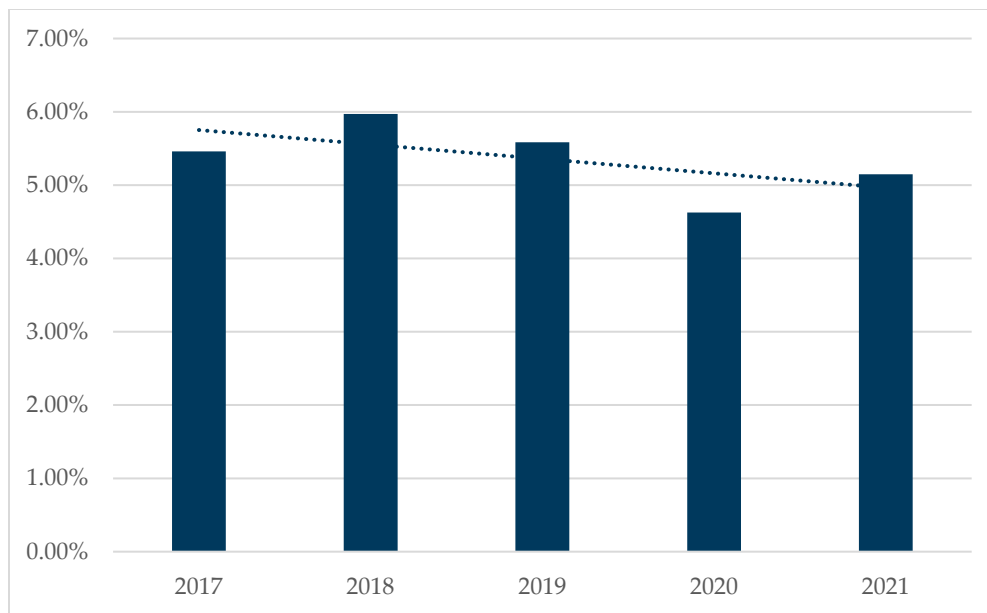
**Figure 2: Western Interconnection Misoperation Rate 2017-2021**

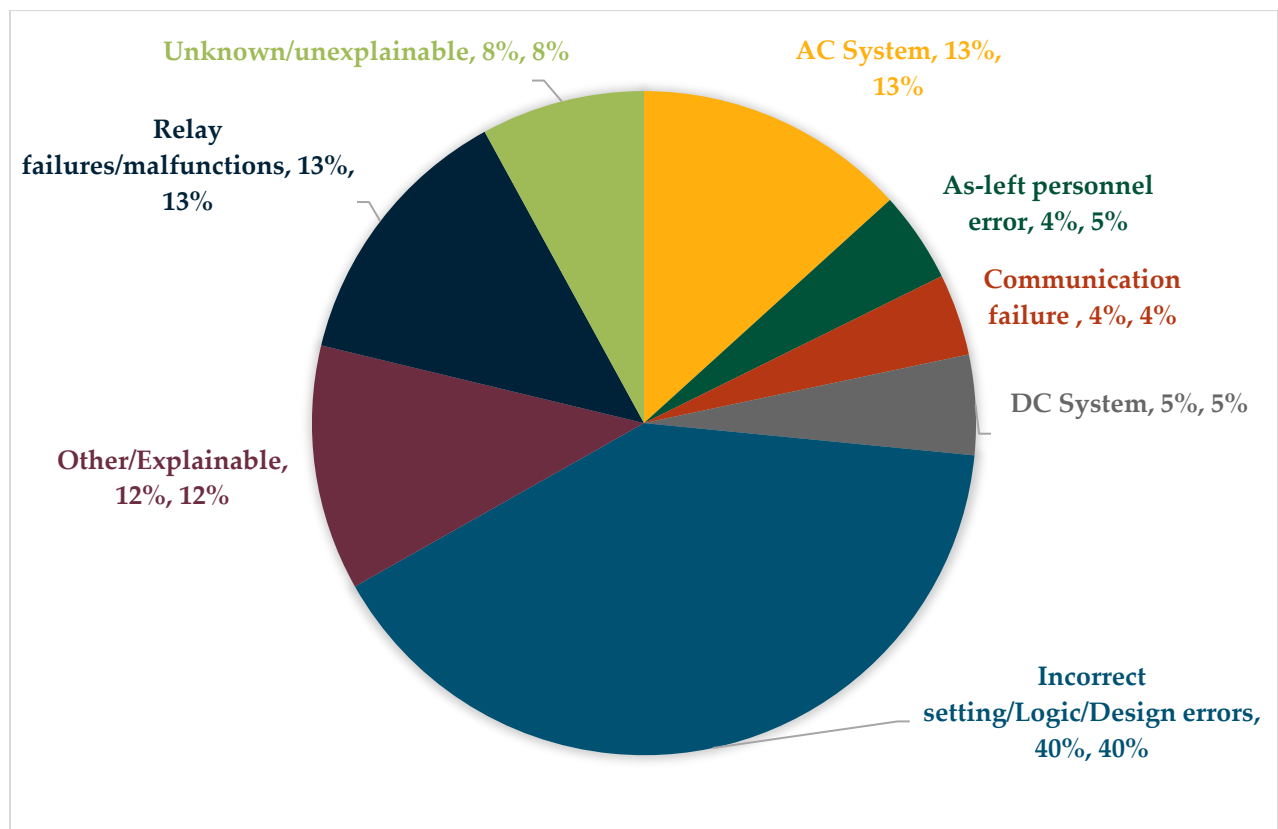
Figure 3: 2021 Misoperations by Cause

Evaluation of misoperations by cause category shows key indicators of misoperations attributed to human performance or a Protection System component. Figure 3 shows the distribution of misoperations as reported by cause category. The “Incorrect setting/logic/design errors” combined into one cause category was the largest, comprising 40% of all misoperations, followed by “Relay failures/malfunction” and “AC System” with 13% each of all reported misoperations. Over half of all misoperations falls into these three categories.

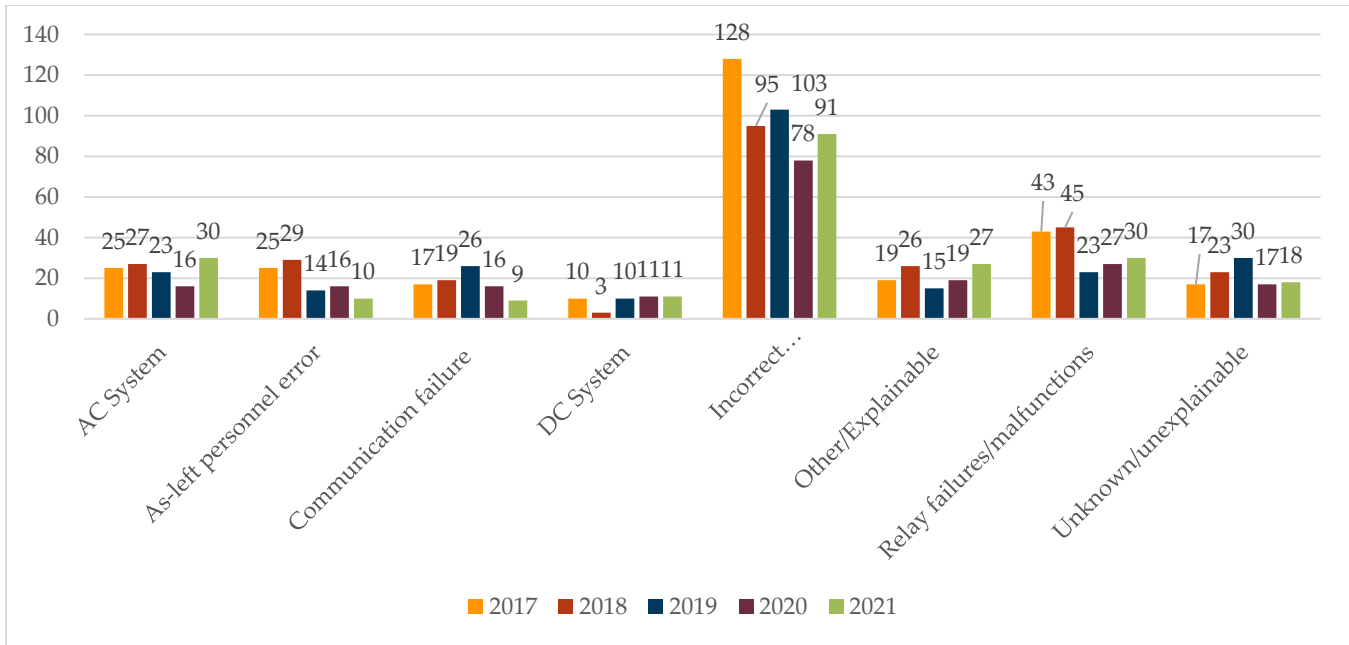
**Figure 4: Misoperation by Cause, 2017 to 2021 Trending**

The trend in Figure 4 shows the top two cause categories for misoperations in the Western Interconnection: “Incorrect setting/logic/design errors,” with a five-year running average of 99 misoperations per year, and “Relay failures/malfunctions,” with an average of 33.6 misoperations a year. Both categories have seen a reduction from the previous years as the total of misoperations is on a downward trend as shown in Figure 1.

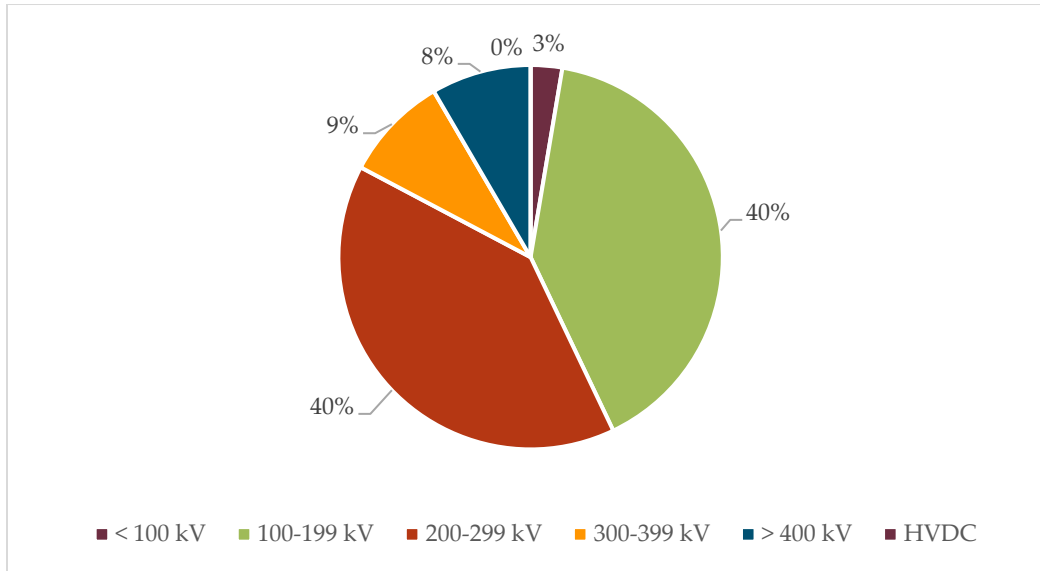
**Figure 5: 2021 Misoperation by Voltage Class**

highest voltage class involved is reported. The number of misoperation by Voltage Class for 2021 is shown in Figure 5.

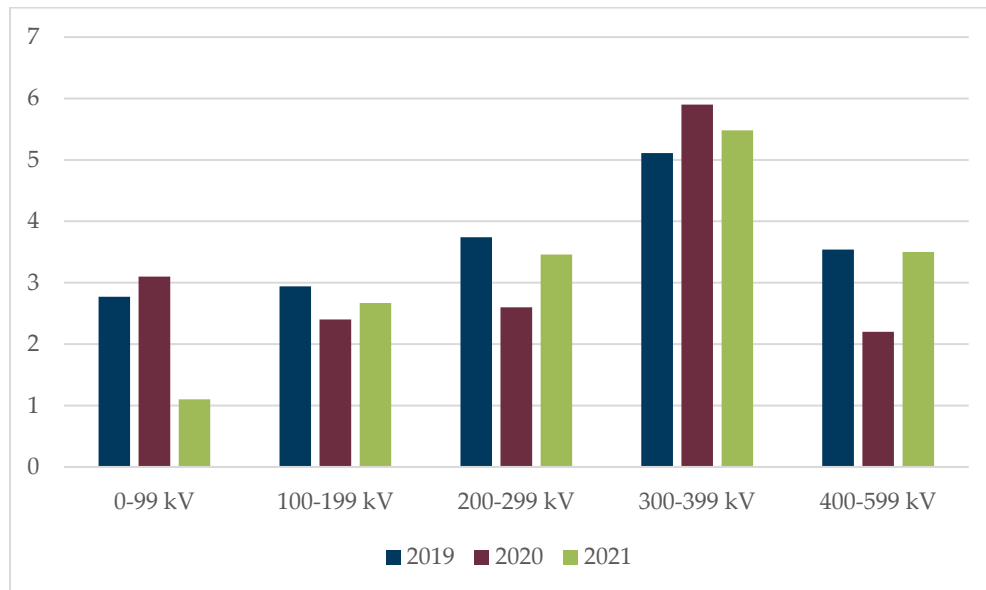
Figure 6: Misoperation Ratio by Voltage Class, 2019 to 2021 Trending

The trend for the misoperation ratios by voltage class Elements for 2019 to 2021 is shown in Figure 6. The chart indicates for most voltages the trend appears constant. Data is only available since 2019 when the RWG adopted the voltage class reporting levels used by NERC MIDAS criteria.

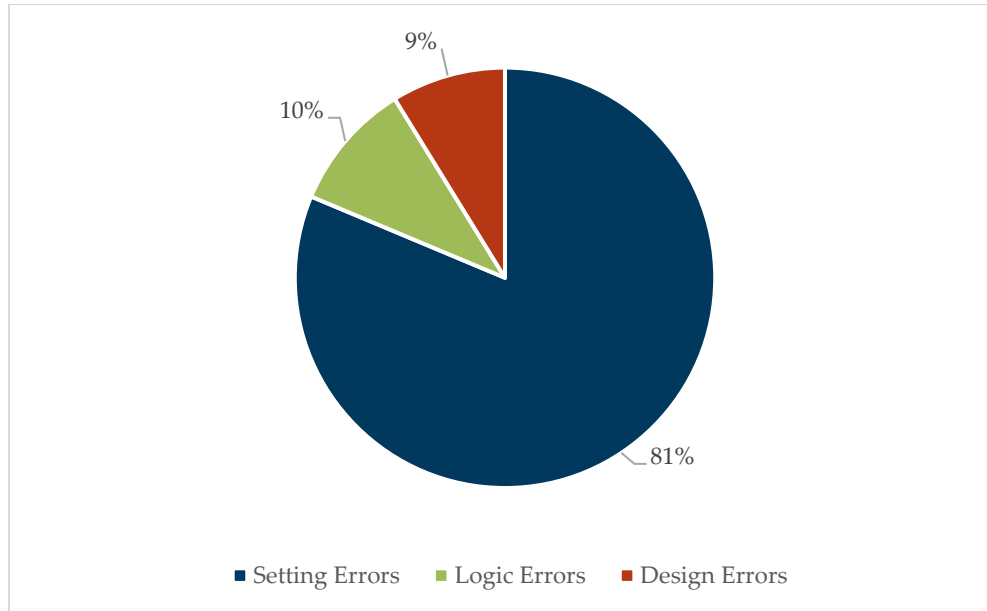
**Figure 7: 2021 Misoperations by Subgroup**

Figure 7 further subdivides the “Incorrect setting/logic/design errors” cause into setting, logic, and design errors. The chart shows setting errors make up 81% of the misoperations, while logic and design errors only account for 19%. This balance is similar to past years (see Figure 8). The percentages suggest

most misoperations are attributed to setting errors, and when considered in conjunction with statistics on relay type, may be indicative of the complexity of microprocessor relays and their applications. The relatively small percentages of logic and design errors might suggest these subgroup have been more standardized for common applications.

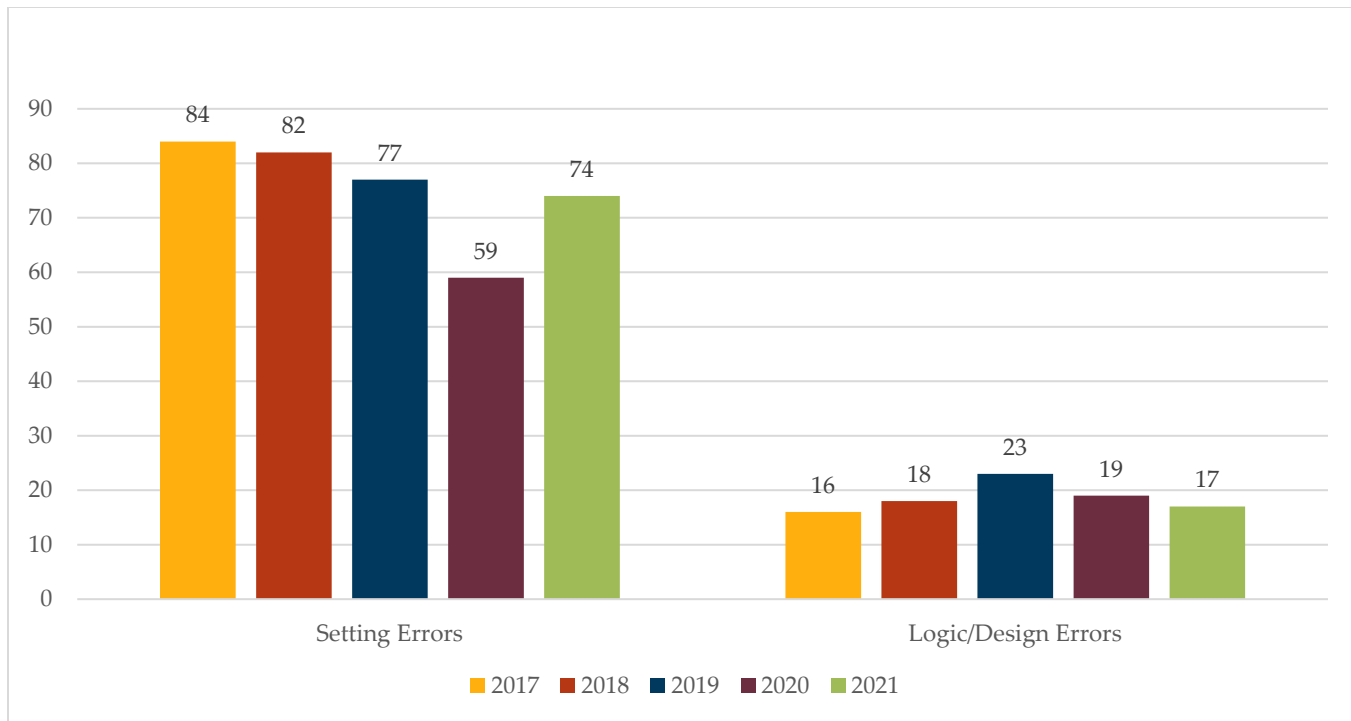
**Figure 8: Misoperations subdivided into Setting and Logic/Design Errors, 2017–2021 Trending**

The trend shown in Figure 8 indicates setting errors continue to be the primary cause of misoperations. However, the trend shows a gradual decrease in the percentage attributed to settings errors, with a corresponding percentage attributed to logic and design errors remaining constant. While the rate of change is small, it may be attributable to factors such as optimizing core relay settings through analyzing operations and misoperations over time.

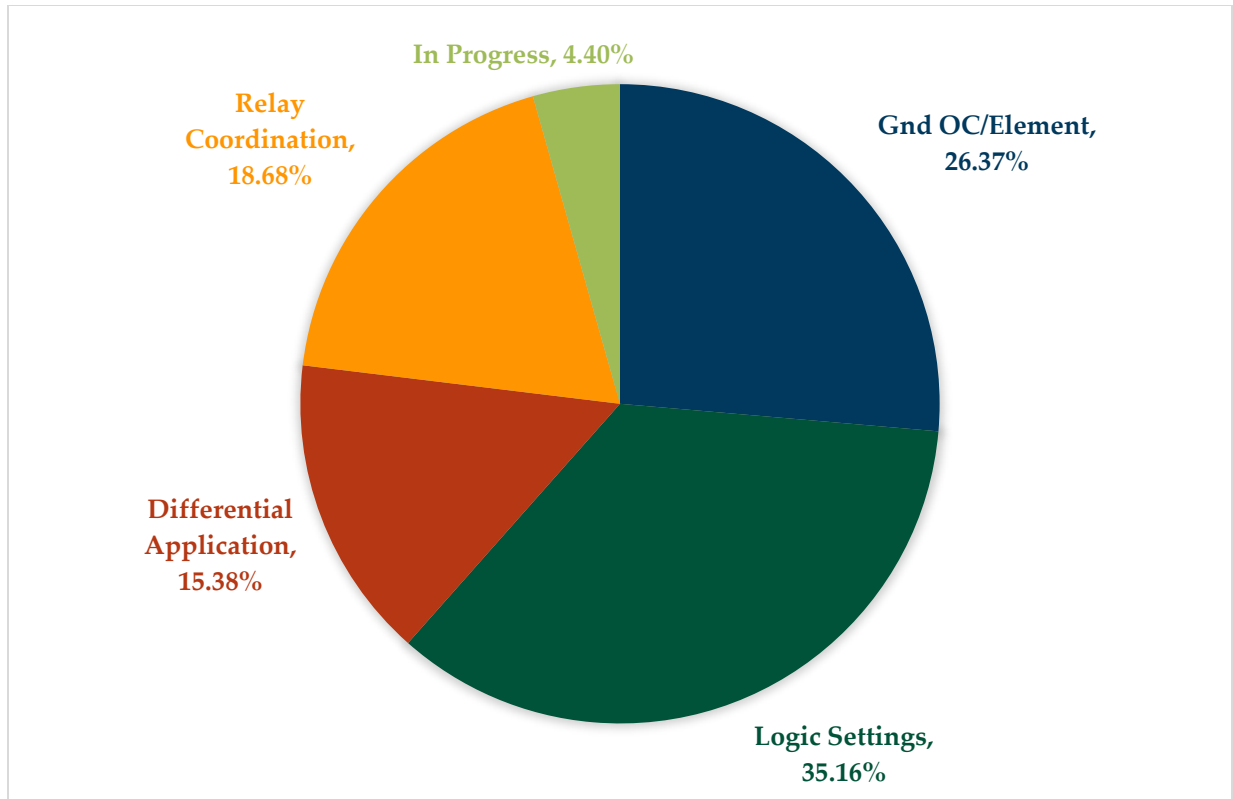
Figure 9: 2021 Settings and Logic/Design Errors by Root Cause

When the errors were further investigated, as shown in Figure 9, three significant causes of misoperations are due to incorrect ground overcurrent/distance settings, logic settings and coordination. Logic settings were defined as directional elements misapplied, outputs not configured correctly, relay to relay communications inappropriately set and corrective action listed as reprogramming. The number of logic errors found in the descriptions does not match the number in the cause identified. Many entities' corrective action plans listed re-coordination of elements as the solution. As in 2020, the number of misoperations in which the cause remained undetermined was zero. A continued improvement of identification is a positive sign. Potential contributing factors include a higher installed percentage of microprocessor relays, in which event record data is easily available and supports misoperations analysis. Most settings and logic/design errors resulted in an "Unnecessary Trip—during fault" removing more elements from the system than necessary.

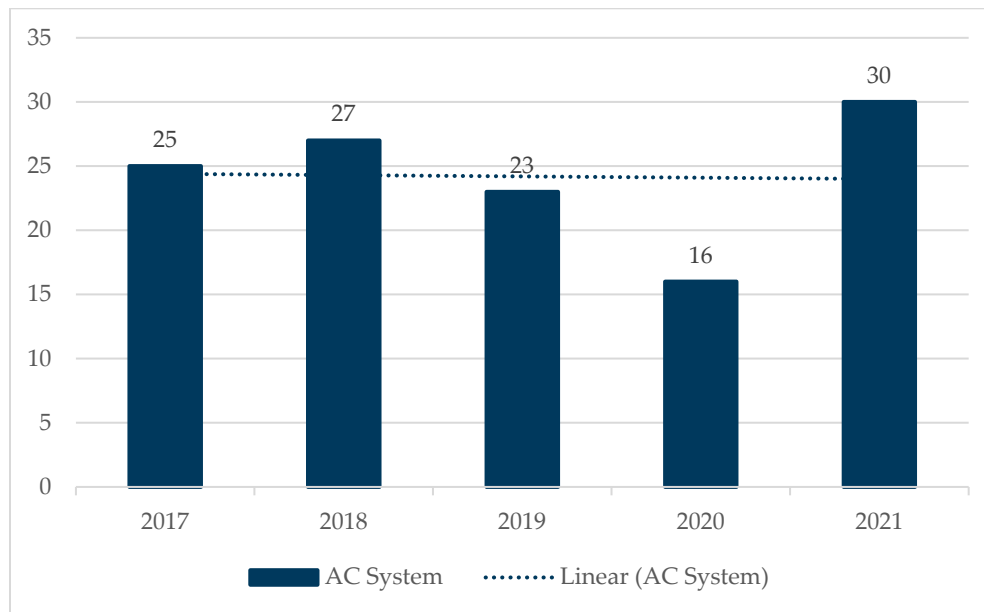
**Figure 10: AC Systems Misoperation Totals, 2017 through 2021**

The 2017-2021 trend of AC failures has been relatively flat, with a reduced number in 2020, Figure 10.

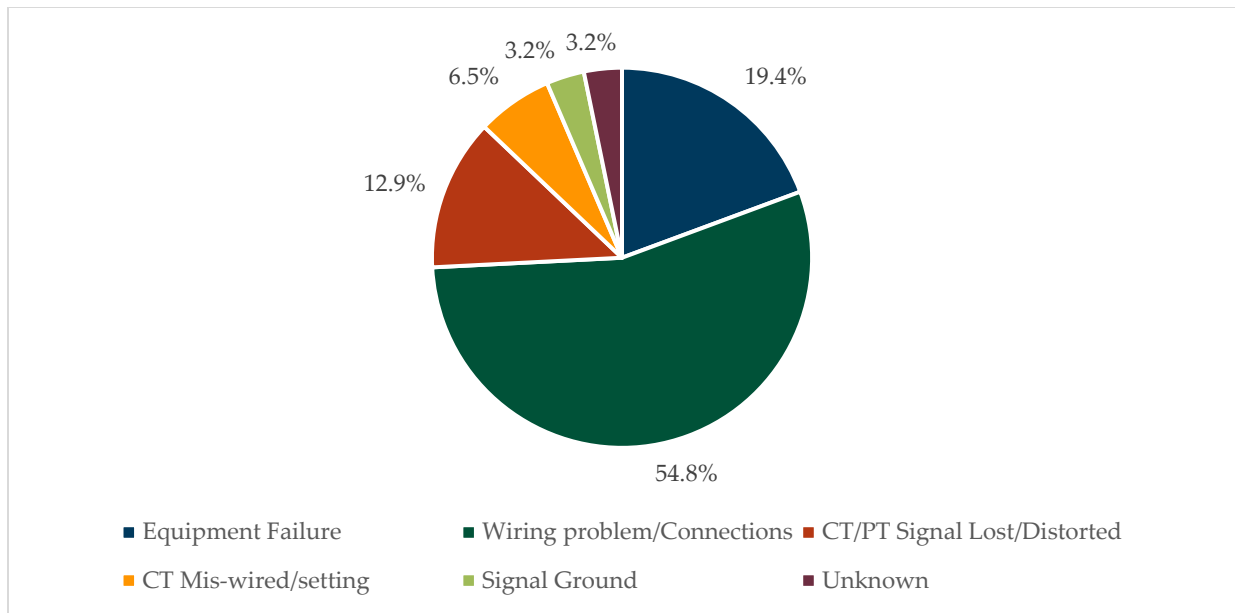
**Figure 11: 2021 AC System Misoperations by Failure Mode**

Through the entity’s reported descriptions of the misoperations and the corrective action plans, the RWG was able to break AC systems into various triggers. The largest source of misoperations in 2021 was CT/PT wiring/connection issues at 54.8%, followed by PT failure (19.4%) and Relay CT/PT Signal lost/distorted (13%), Figure 11.

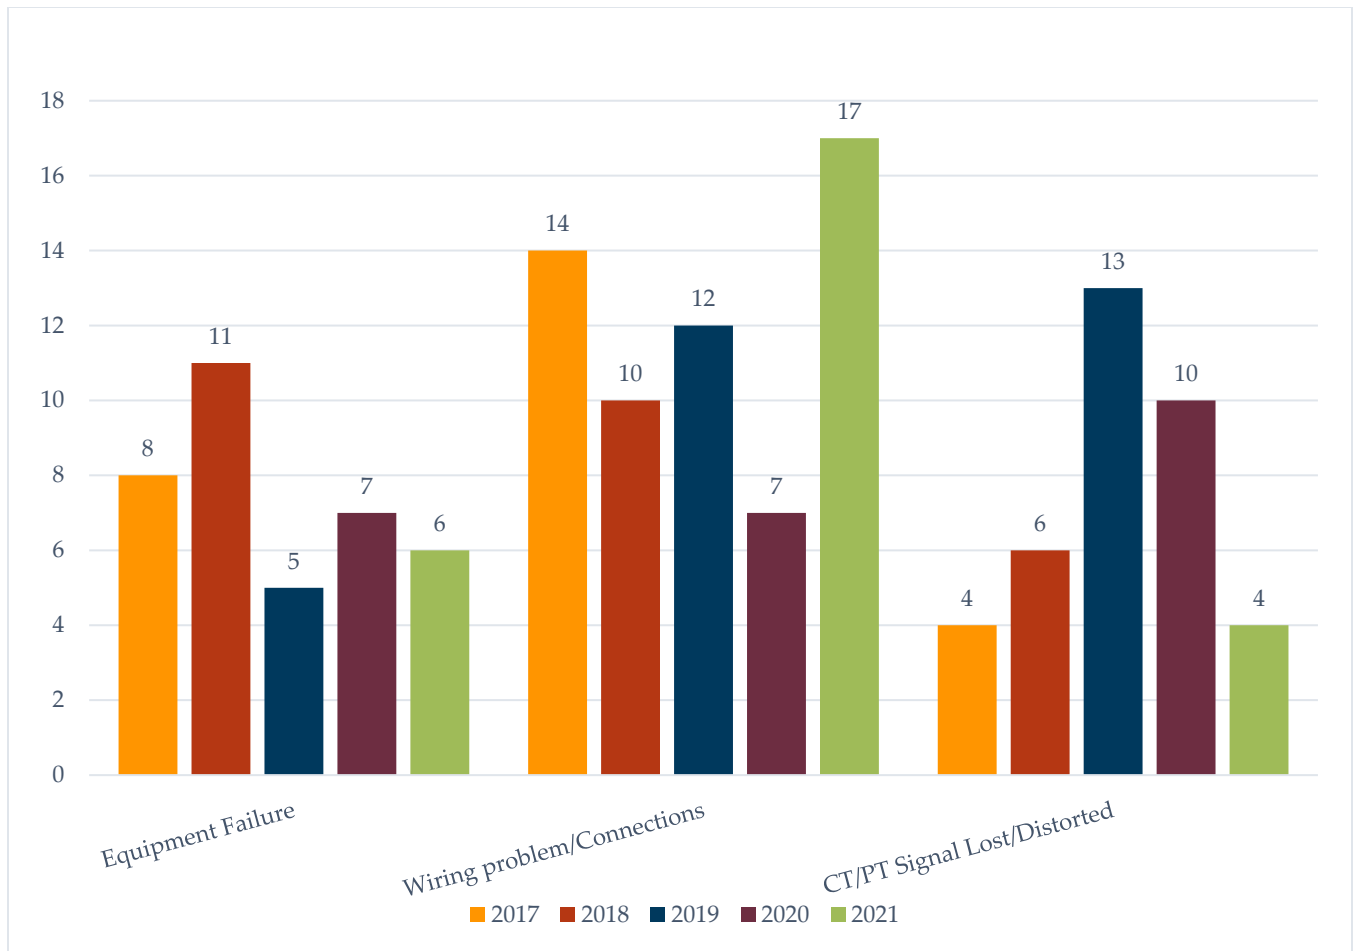
**Figure 12: AC Misoperation 2017-2021 trend by Failure Mode**

Seventy percent of the AC System Misoperations were categorized as Unnecessary Trip—Other than Fault. A majority of the Unnecessary Trip—Other than Fault are attributed to CT/PT Wiring/Connections issues. Highlighting the top three triggers from the 2017–2021 indicates that Wiring problem/Connections, by average, is the leading cause, shown in Figure 12.

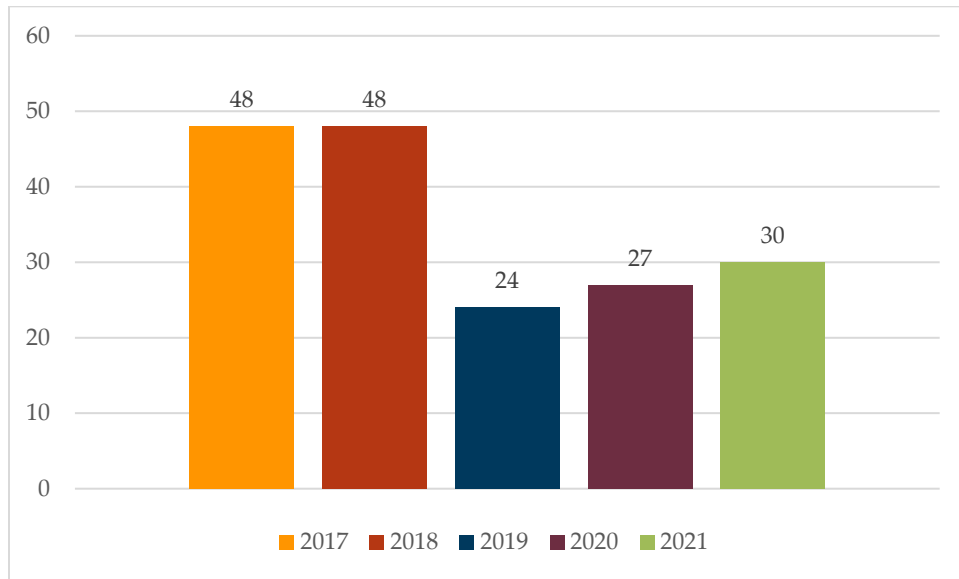
**Figure 13: Relay Failures and Malfunctions, 2017-2021 Trending**

There were 30 misoperations attributed to “Relay failures/malfunctions” in 2021. Figure 13 shows the number of misoperations for this cause is higher than the previous two years, but significantly lower than in 2017 and 2018.

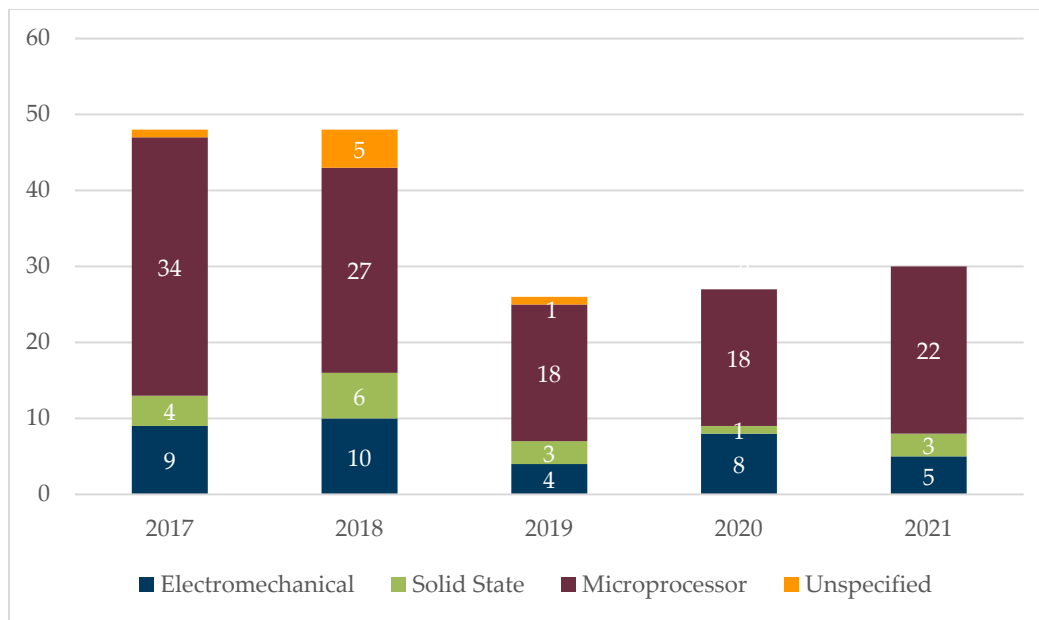
**Figure 14: Relay Failures and Malfunctions by Equipment Type**

Figure 14 shows the distribution of these misoperations by relay technology. Microprocessor relays continue to be the most common relay type associated with relay failures. They consistently represent 60% to 70% of all relay failures. Overall, relay failures have declined for the years 2019, 2020, and 2021 compared to 2017 and 2018. Interestingly, there has not been a significant change in the percentage of failures attributed to microprocessor relay type during the last three years. Since all new installations employ this relay type, it is believed that they will continue to represent a greater and greater percentage of the total relay inventory, which may result in representing a greater percentage of the relay failures as well. Since a complete inventory of relays is unavailable, we cannot say whether these relays have a higher failure rate than other relay technologies.

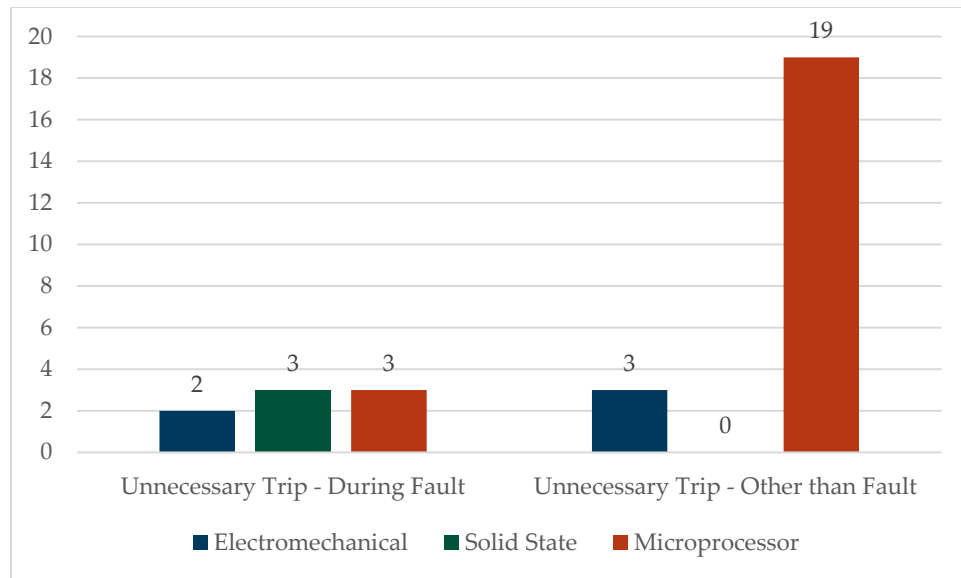
**Figure 15: 2021 Relay Failures/Malfunctions Misoperations by Category**

Reported relay failures for 2021 were analyzed as a function of the technology versus the misoperation category in Figure 15. Most relay failures caused an “Unnecessary trip—other than fault,” indicating these failures are prone to cause a trip without a fault present. This cause often has a lower impact than a failure of a relay to detect and clear a fault from the system. We were pleased to see no failure or slow trip misoperations in 2021.

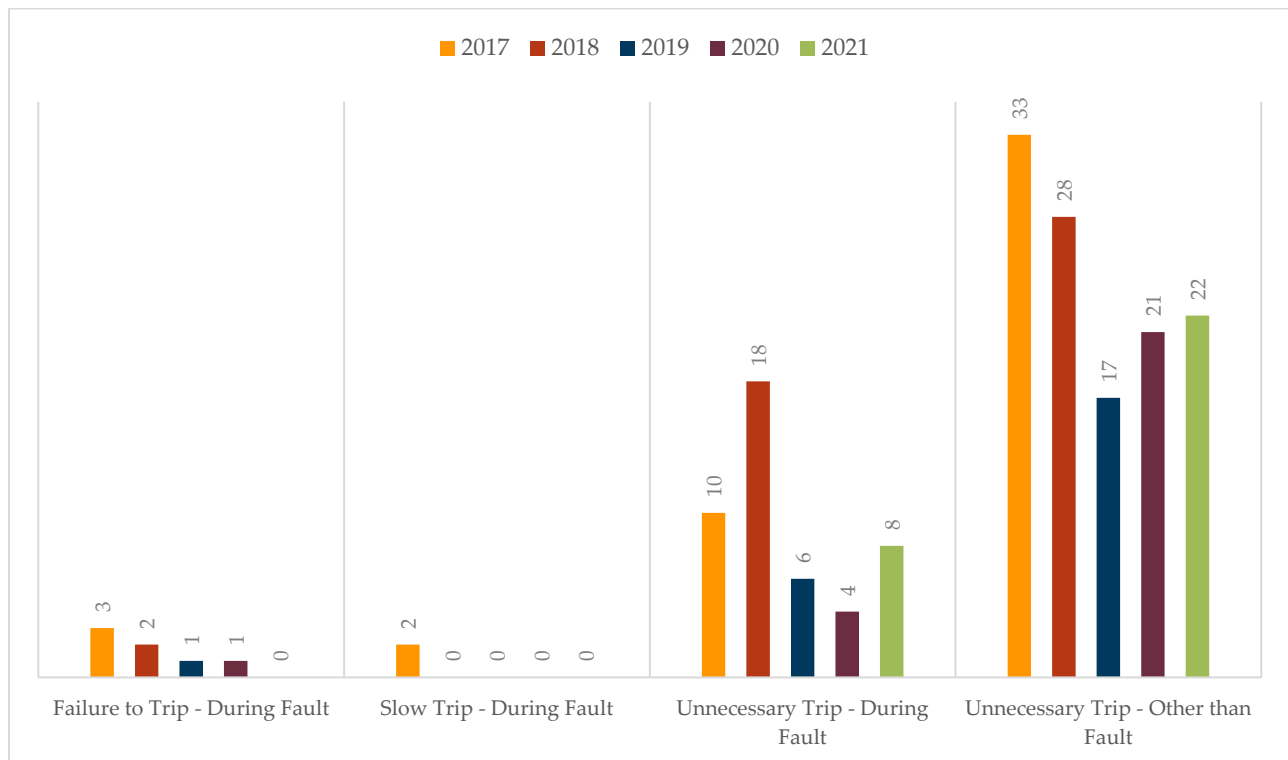
**Figure 16: Relay Failures/Malfunctions Misoperations by Category, 2017-2021 Trending**

Figure 16 shows previous years are similar to 2021, in that most relay failures result in an “Unnecessary trip—other than fault.” Failure to trip and slow trips remain at low levels through the trending timeframe.
