2022 Protection Systems Performance Report

Protection and Controls Subcommittee

October 18, 2023

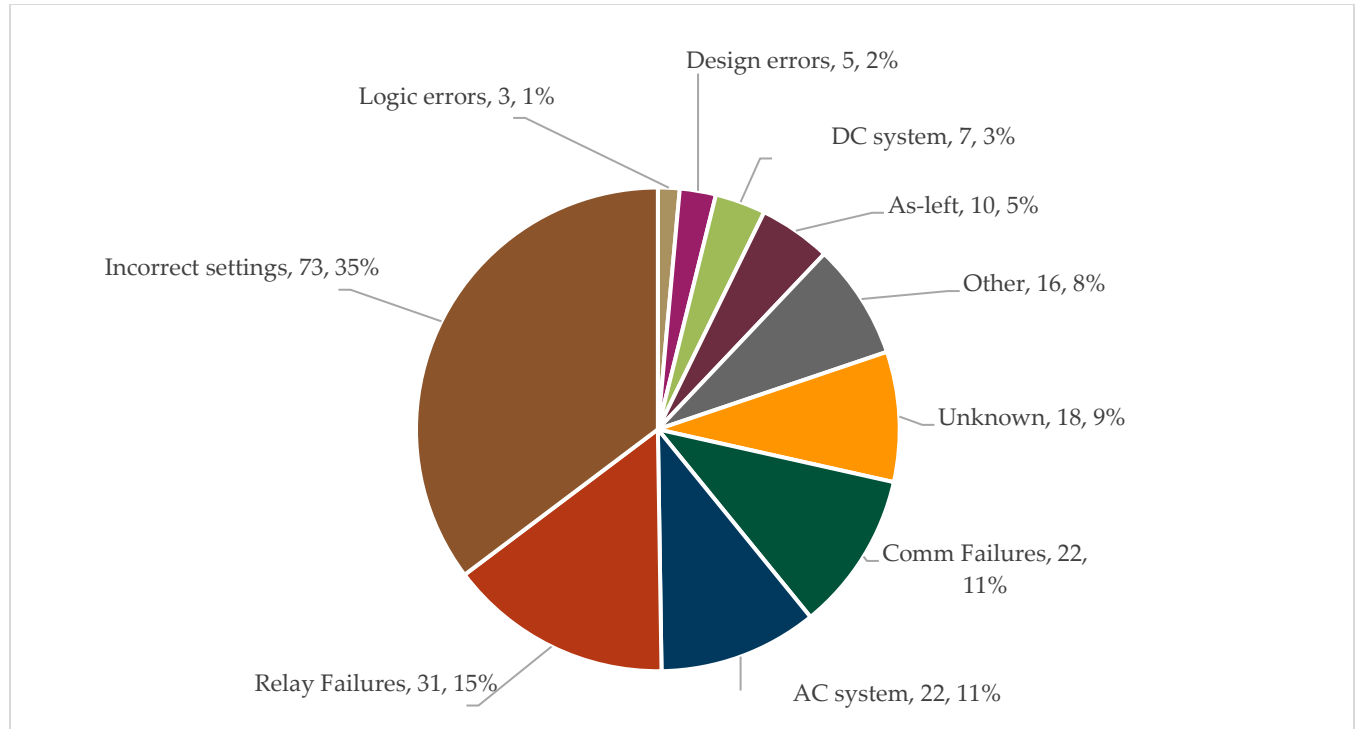
Evaluation of Misoperations by cause category shows key indicators of Misoperations attributed to human performance or a Protection System component. Figure 3 shows the distribution of Misoperations as reported by cause category for 2022. For this analysis, the "Incorrect setting/logic/design errors" categories are combined into one category. This combined category is the

largest contributor to Misoperations in the Western Interconnection. In 2022 this category represented 38% of all Misoperations, followed by “Relay failures/malfunction” with 15%, and AC Systems and Communications Failures with 11% each. Two-thirds of all Misoperations for 2022 fall into these cause categories.

Figure 3: 2022 Misoperations by cause

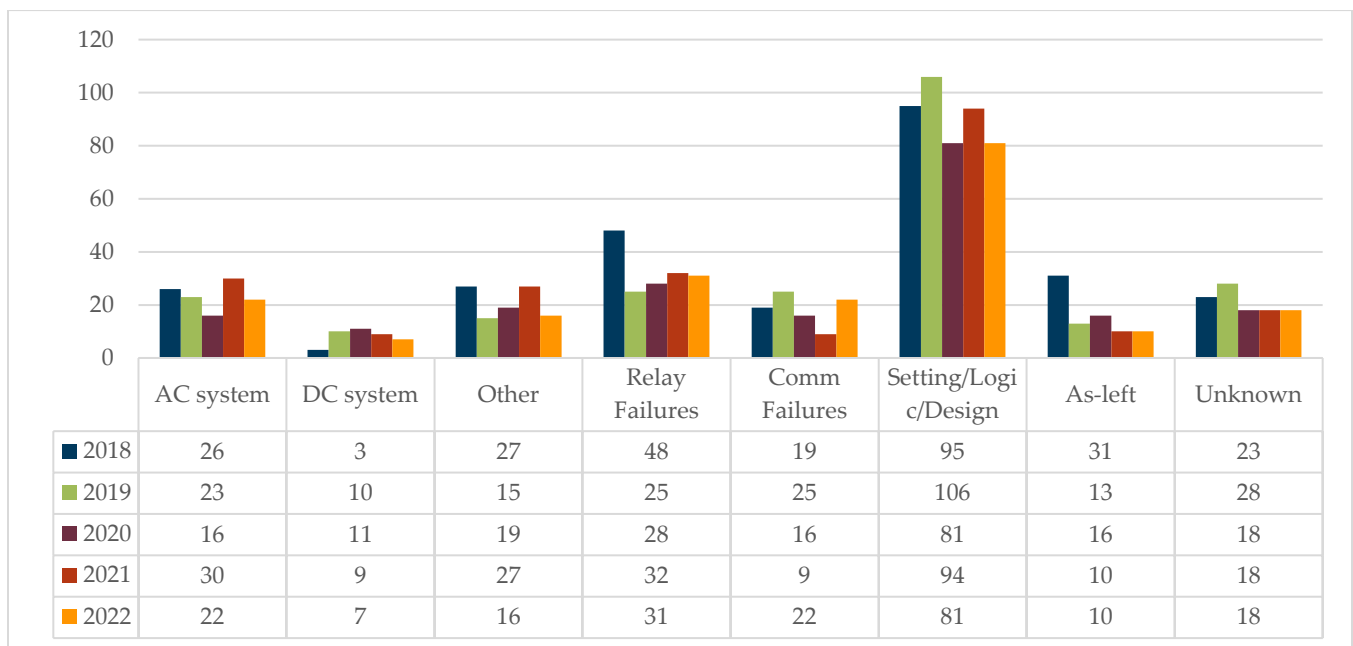
Figure 4 shows that the Incorrect Settings/Logic/Design Errors and Relay Failure/Malfunctions categories have consistently been the highest contributors to Misoperations over the past five years. A positive observation is the reduction in the number of Misoperations with an unknown cause over this period. Misoperations for which a cause is not identified are concerning because it becomes difficult to create an effective Corrective Action Plan when the root cause is unknown, and the Protection Systems involved are prone to repeated Misoperations when similar system conditions are present.

Figure 4: Trending Misoperation by cause from 2018 through 2022

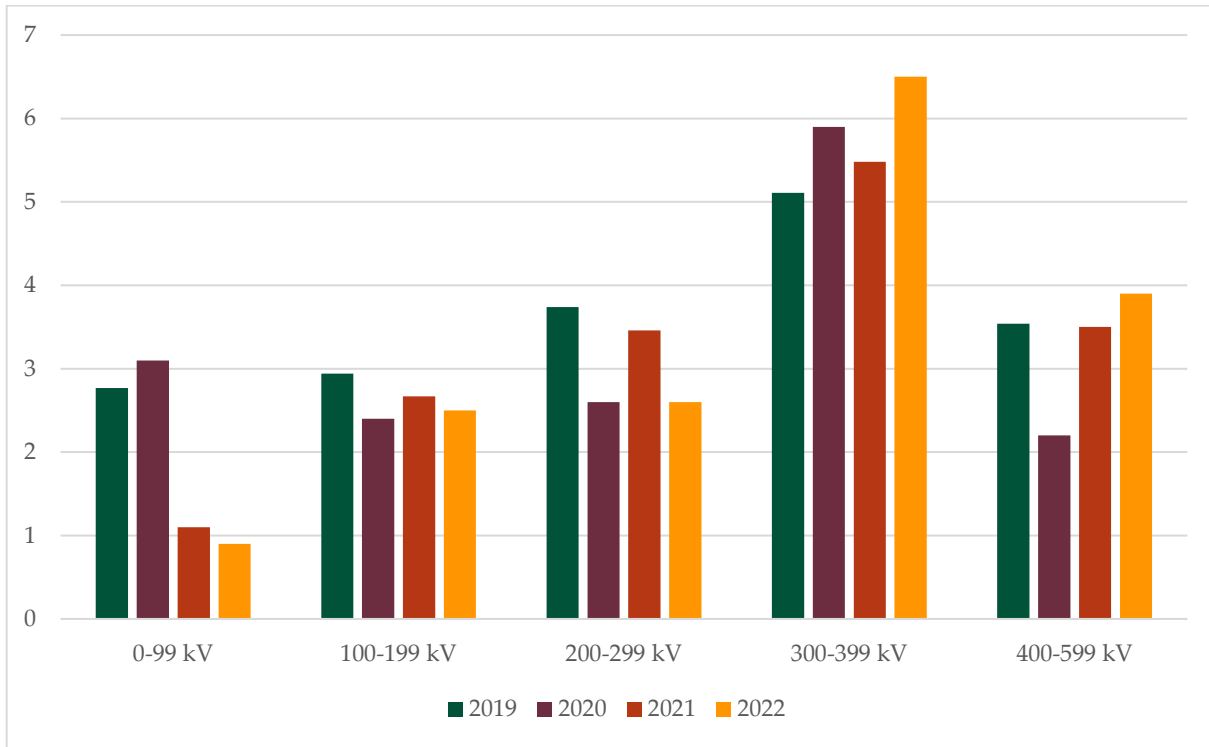
The four-year trend in Figure 9 shows that Misoperation ratios by voltage class have stayed fairly constant. However, there is a decrease in the 0–99 kV voltage class. Data is only available since 2019 when the PCS adopted the voltage class reporting levels used by NERC MIDAS criteria.

Figure 9: Misoperations per 100 TADS Elements in voltage class, 2019–2022 trending

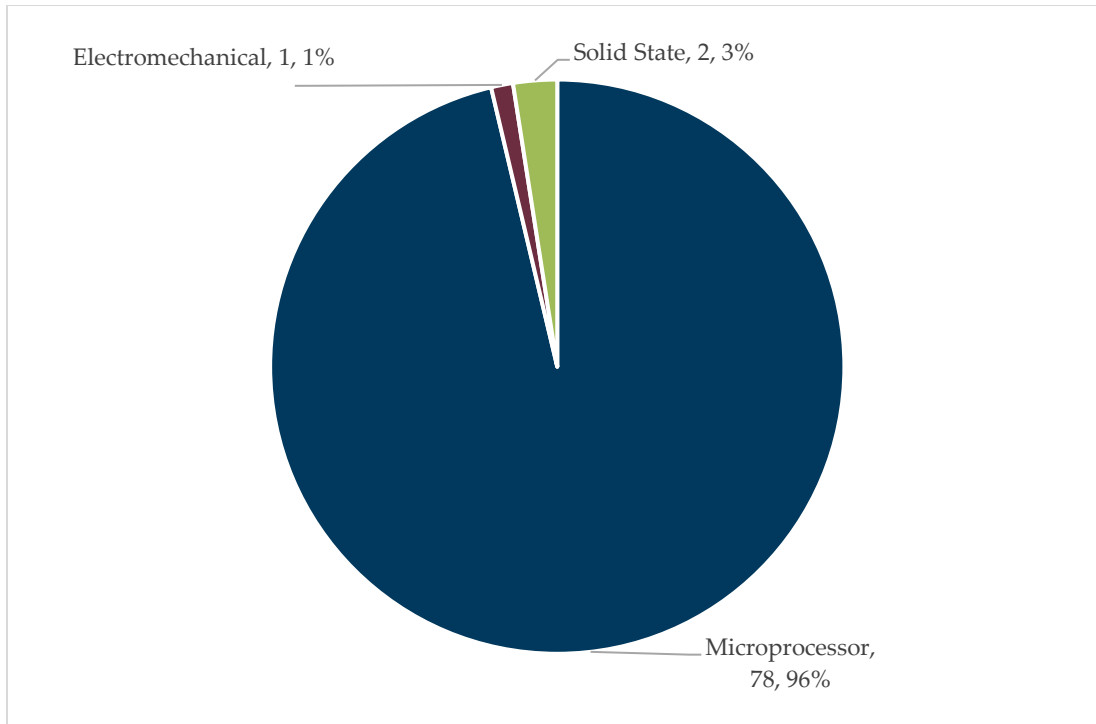
There were 81 Misoperations attributed to “Incorrect setting/logic/design errors,” which is a decrease from 2021. However, this is still by far the largest of all cause categories in 2022. Figure 10 shows that 96% of the Misoperations caused by incorrect settings, logic, design errors were on microprocessor relays.

Figure 10: 2022 Misoperations by relay technology

The large number of Misoperations suggests the widely adopted use of microprocessor technology. While microprocessor relays provide enhanced event analysis capabilities that assist in Misoperation diagnosis, there is additional complexity that contributes to the number of Misoperations associated with this relay technology. Eventually all of the Misoperations may be caused by microprocessor-based relays when older technologies have been entirely replaced.

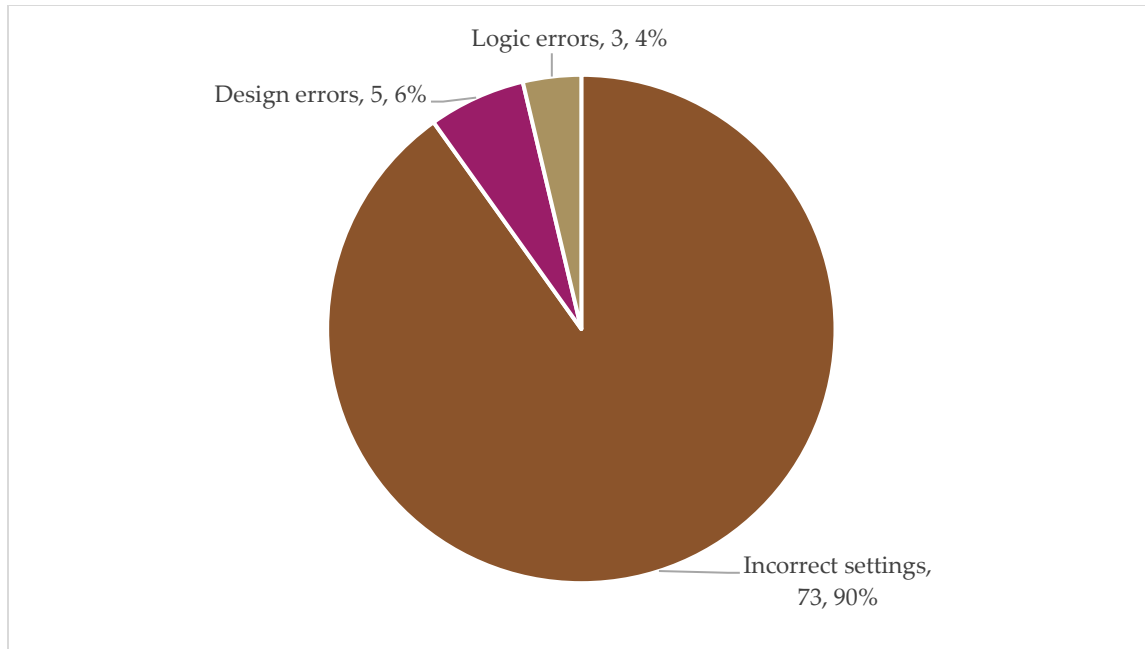
Figure 11 further subdivides the “Incorrect setting/logic/design errors” cause into setting, logic, and design errors. The chart shows setting errors make up 90% of the Misoperations, while logic and design errors only account for 10%, which is about half of the percentage reported in 2021. The trend from the last five years is shown in Figure 12. Knowing most Misoperations are attributed to setting errors, and when considered in conjunction with statistics on relay type, may be indicative of the complexity of microprocessor relays and their applications. The relatively small percentages of logic and design errors suggests these subgroups have become more standardized for common applications.

Figure 11: 2022 Misoperations by subgroup

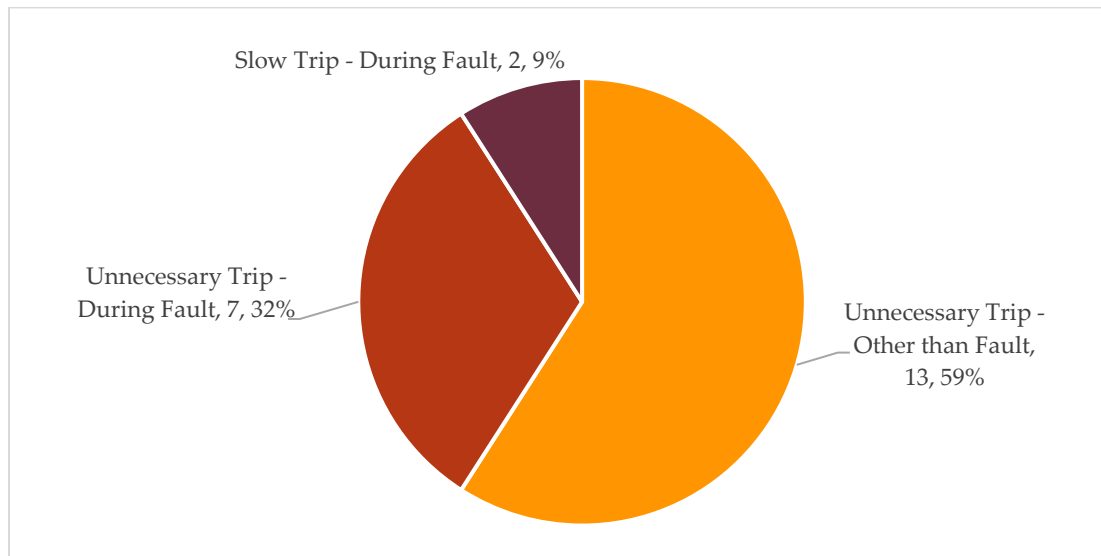
Figure 21 shows the 2022 communication failure related Misoperations by category. Over half of the Misoperations resulted in unnecessary trips without a fault on the system. Of concern is the two slow trips during faults. These are generally considered higher severity Misoperations.

Figure 21: 2022 communication failure Misoperations by category

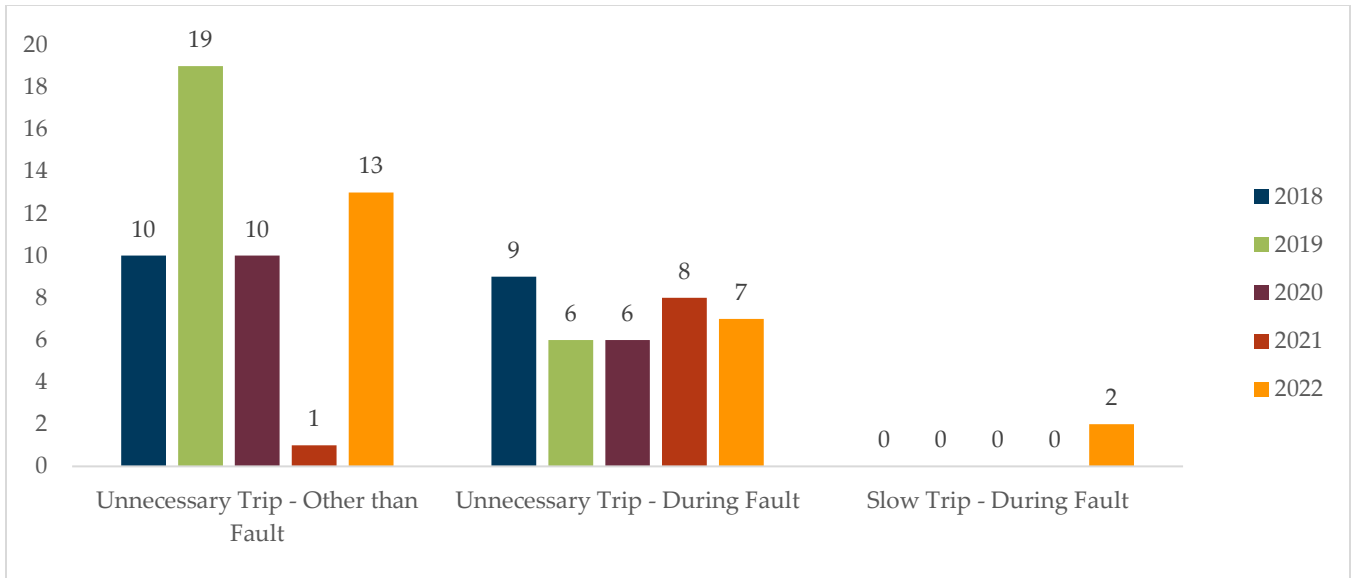
Figure 22 shows these are the only two slow trip during fault Misoperations involved in communication failure Misoperations over the past five years. One of these involved a three-terminal POTT scheme on a 230 kV system that did not operate correctly during a single-line-to-ground fault, requiring remote protection to clear the fault from the system. The other took place on a 115 kV system where the transfer trip signal was not received during a single-line-to-ground fault.

Figure 22: Communication failure Misoperations by category, 2018–2022

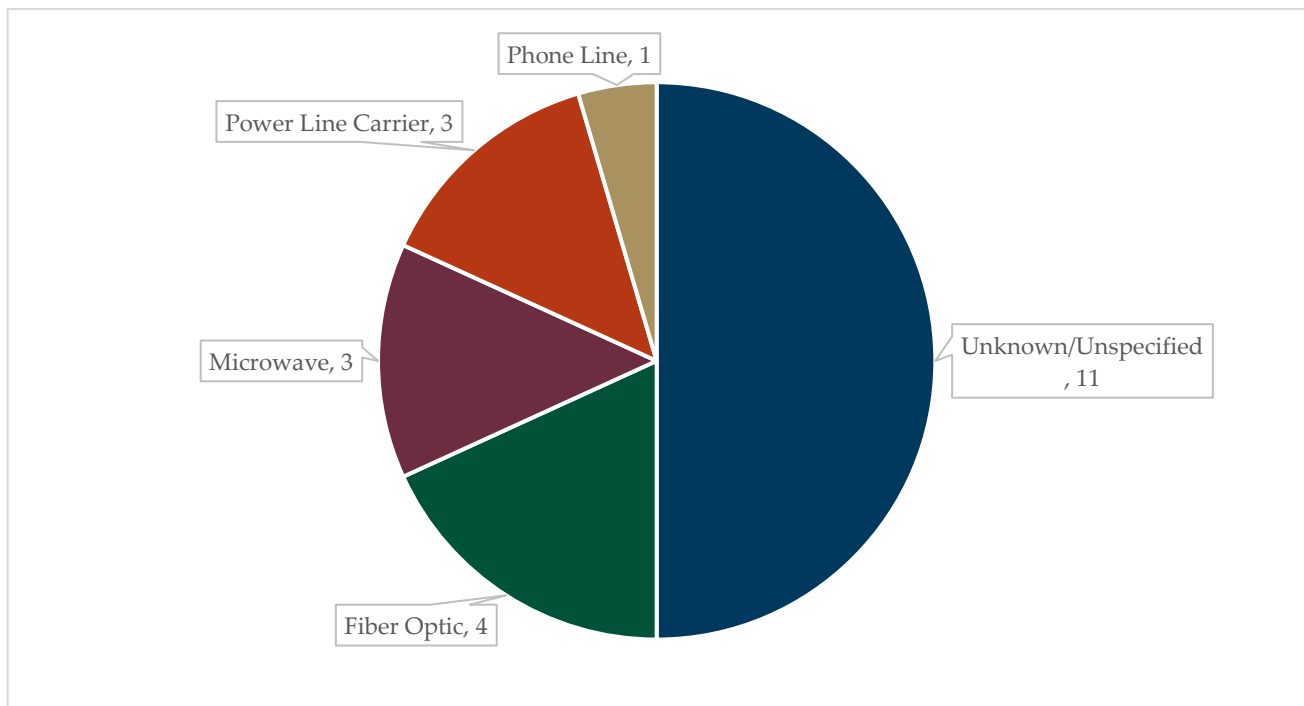
Figure 23: 2022 communication-related protection Misoperations by communication system type

Figure 23 shows the breakdown of communication-related Misoperations by communication system type. The data shows that half of the submissions did not include this detail. The Communication System Type is an optional field in MIDAS, and this information was not provided in this field, or in the event descriptions for half the submissions for 2022.

There were more Misoperations due to communication failures in 2022 than in all but one year over the past five years. The high number of unspecified communication system types makes it difficult to determine what communication method led to the increase. Communication Misoperation causes may increase as entities move to new technology and packet-based communication systems for use in Protection Systems. Migration to new technology, in particular packet-based, has not widely occurred. The impact of implementation of new communication system technology on Misoperations is not well understood. It may be that current installations are not causing Misoperations, or there is not enough detail in the Misoperation submission data fields to show the type of technology used. When employing new technology, thorough testing and verification should be performed to ensure Protection System reliability.
