# Is WR1.4 Working as Intended? Case Study from TPL

WECC MVS meeting, May 2025

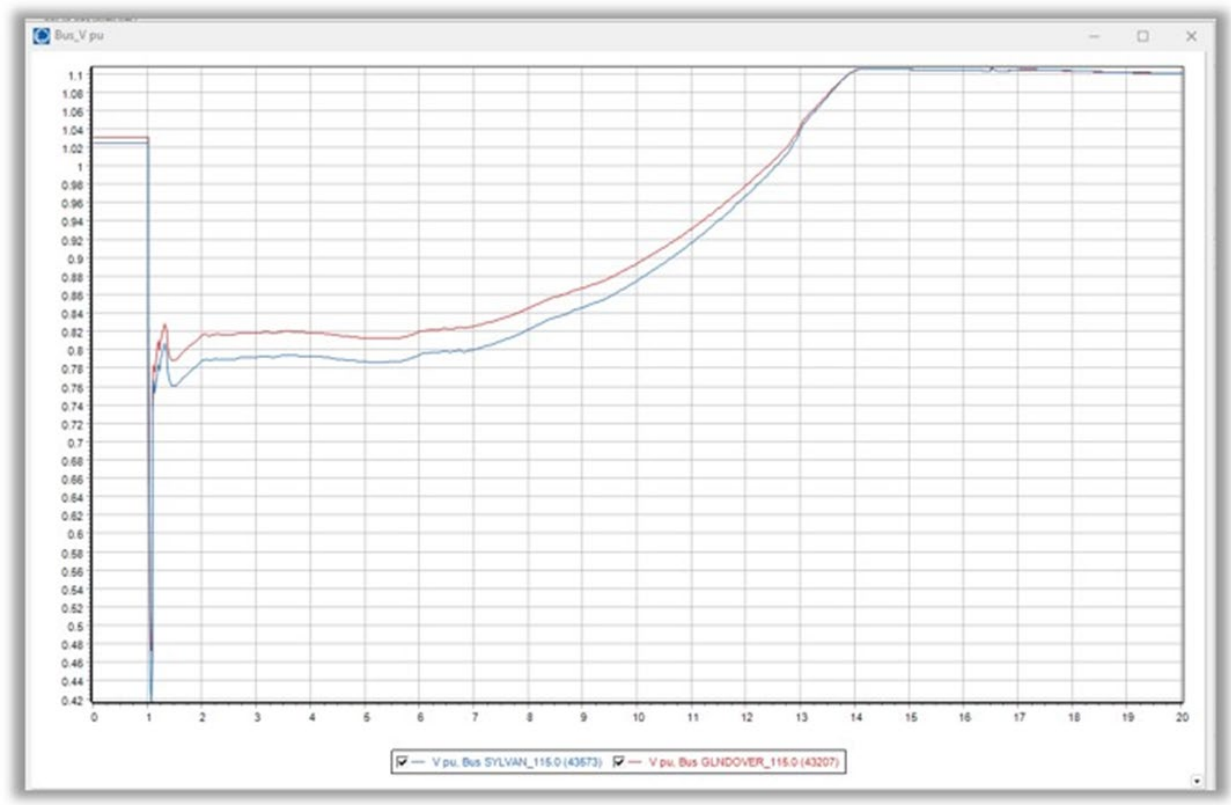
- During a P1-2 fault on a 500kV line in Northwest, two nearby buses behaved differently:
  - One 115kV (Red):
    - Recovered above 0.8 pu, then dipped again below for >2 sec → Violation triggered
  - Another 115kV (Blue):
    - Never recovered to 0.8 pu (only ~0.78 pu) → No violation triggered

- The issue isn't just waveform quality—it's how the WR1.4 logic structure fails to capture certain problematic behaviors
- “Red” Voltage looks better but is flagged
- “Blue” Voltage looks worse but is not flagged

- The logic activates the 2-second timer after recovery >80%
- Therefore, worse performance (never recovering) avoids violation
- This creates a loophole: inferior dynamics pass, while better dynamics get flagged
